NATIONAL TRANSPORTATION SAFETY BOARD

SPECIAL INVESTIGATION REPORT

SURVIVAL IN HAZARDOUS MATERIALS TRANSPORTATION ACCIDENTS

NTSB-HZM-79-4

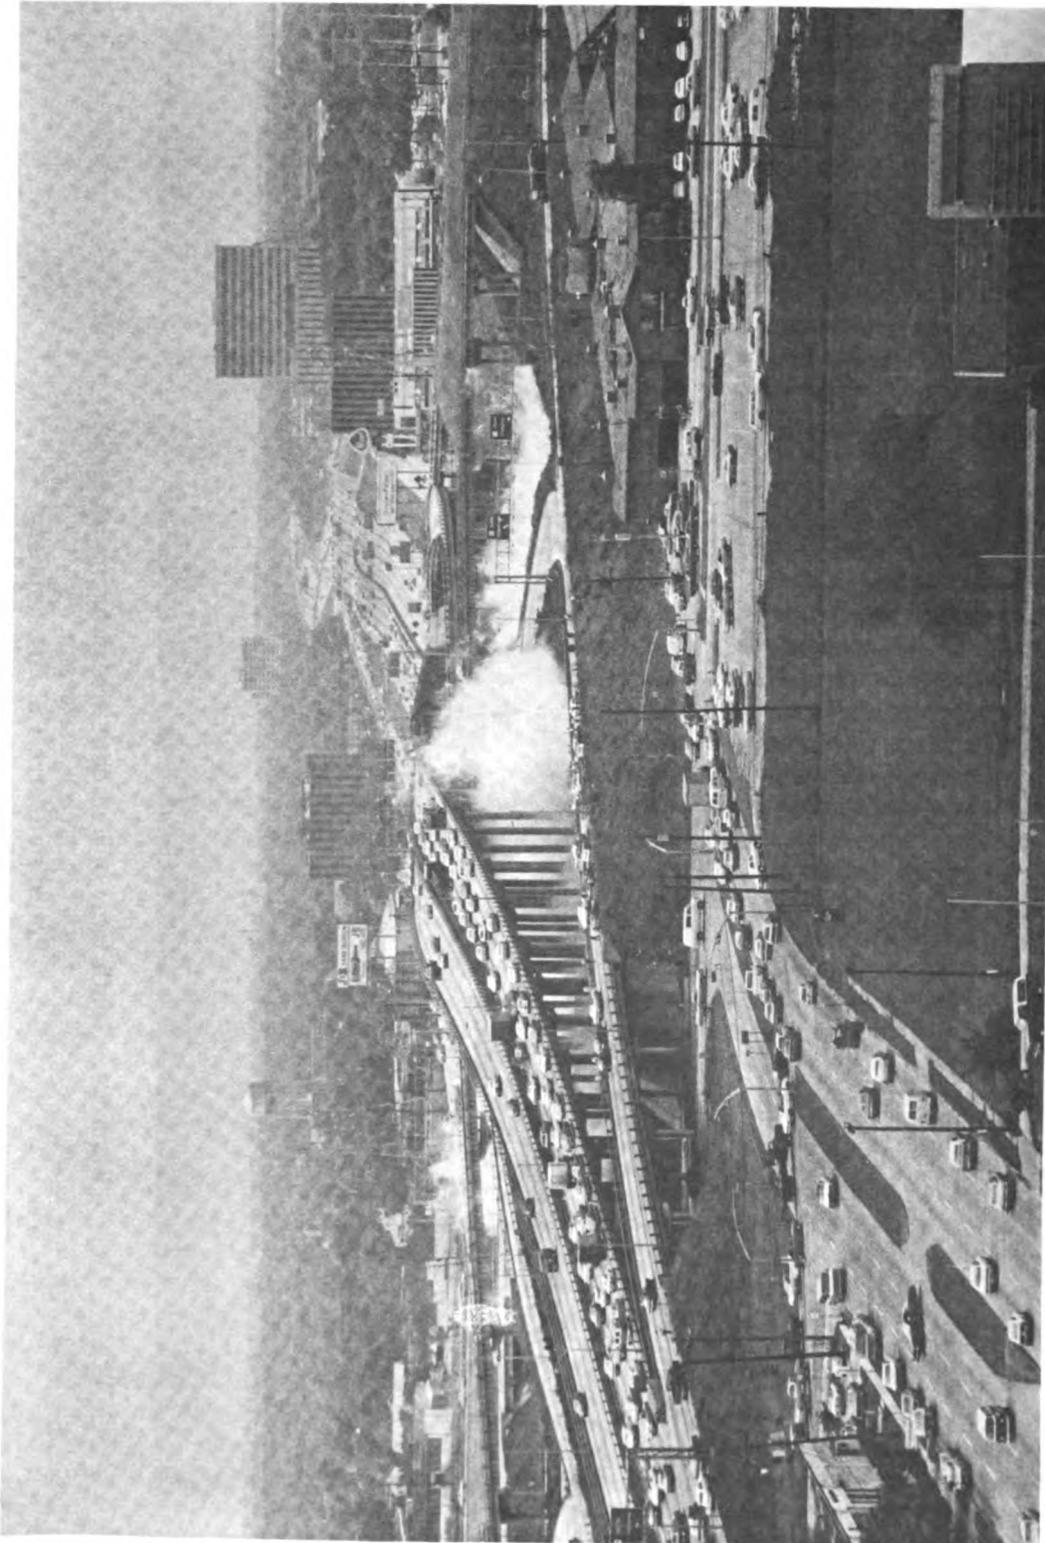
Some of the ammonia vaporized and formed a large gas cloud. (See figure 2.) As the cloud absorbed heat from the surrounding warm air, it became buoyant and began to rise from the surface into the atmosphere. As the buoyant gaseous ammonia was carried upward, the cloud was limited and directed downrange by a moist, 7-mph wind. (See figure 3.) The meteorological conditions at the crash site and the large amount of suspended ammonia maintained noxious concentrations of ammonia droplets 3,000 feet downwind for 3 to 5 minutes. (See figures 4 and 5.) Cold liquid ammonia flowed along the contours of the ground and formed in pools along the ditches bounding U.S. 59. The advancing cloud caused exposed vegetation to temporarily brown. (See figure 6.)

**Figure 5. North view of accident site showing cloud at 4 minutes
after the crash.
(Photo by Carroll S. Grevenberg)**

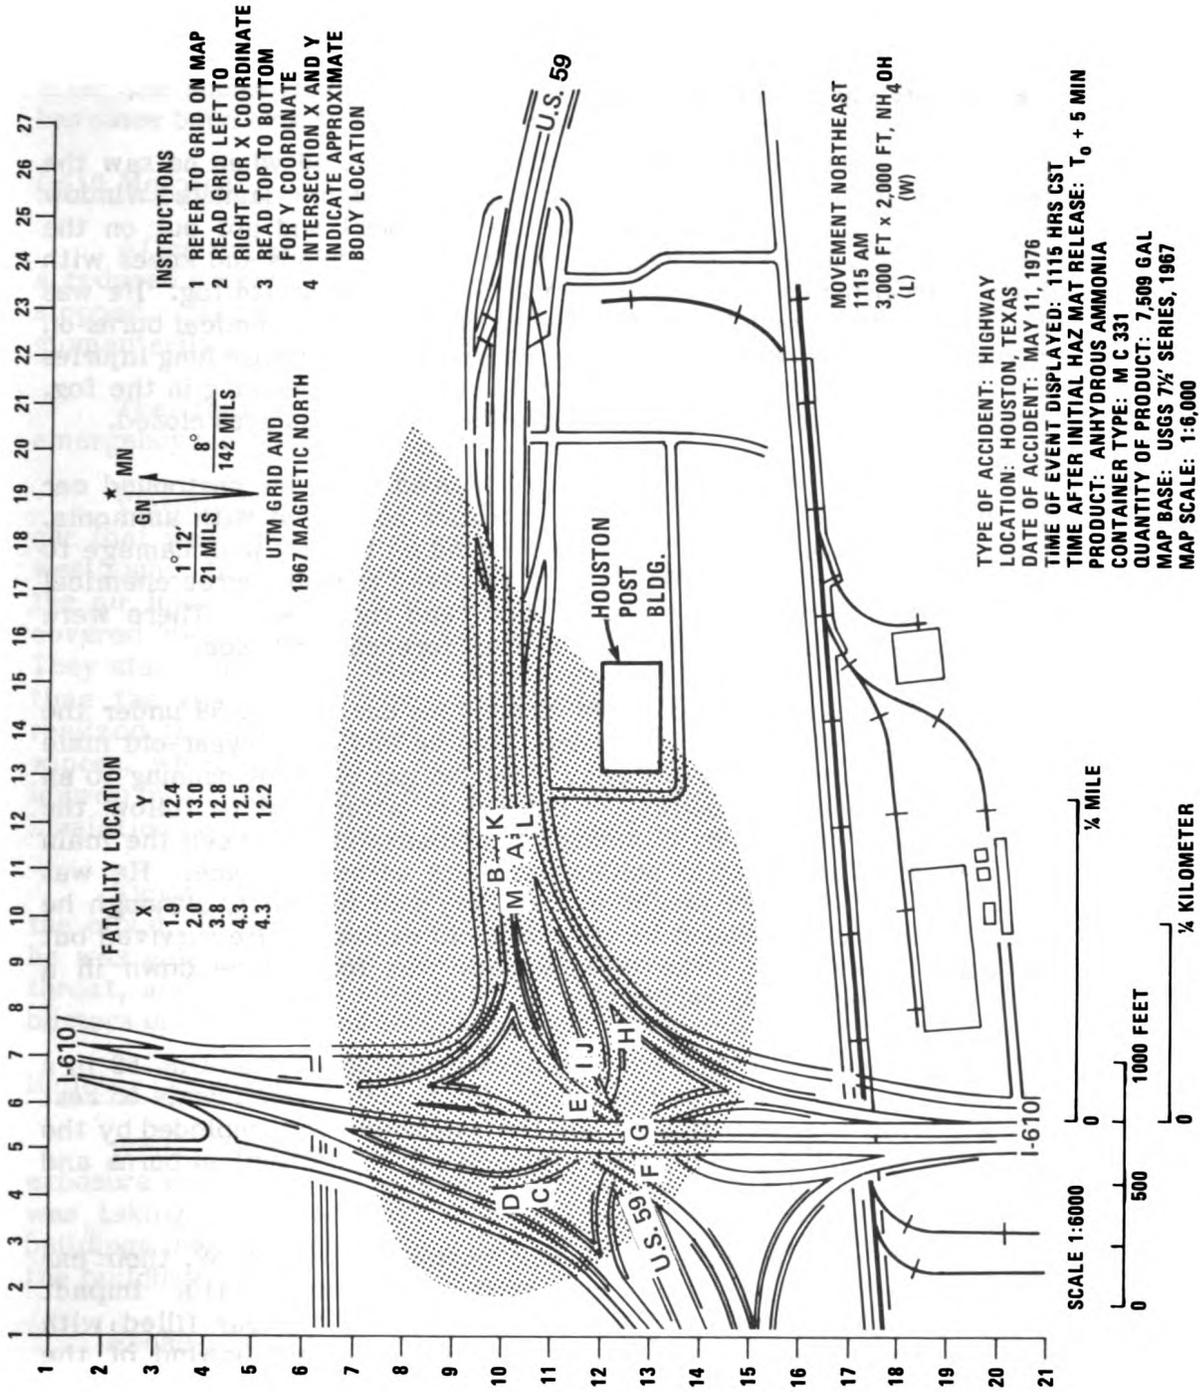
The following cases explain in more detail how some motorists on U.S. 59 reacted to the emergency (see figure 7):

Figure 7. Location when rescued of victims discussed in case histories.

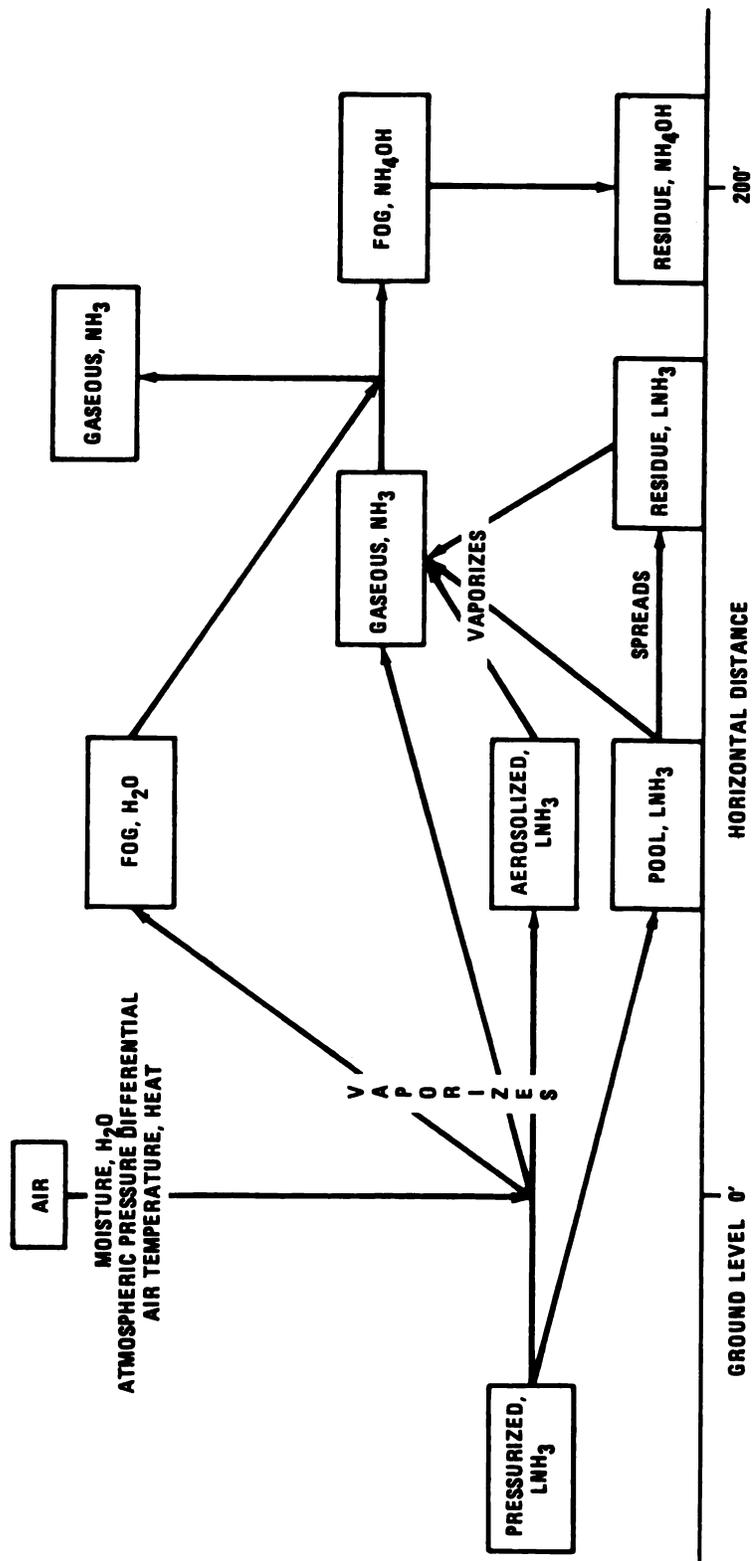
Figure 8. Formation of 1st puff between T_{O} (time when ammonia first released) and $T_{\text{O}} + 1$ minute.

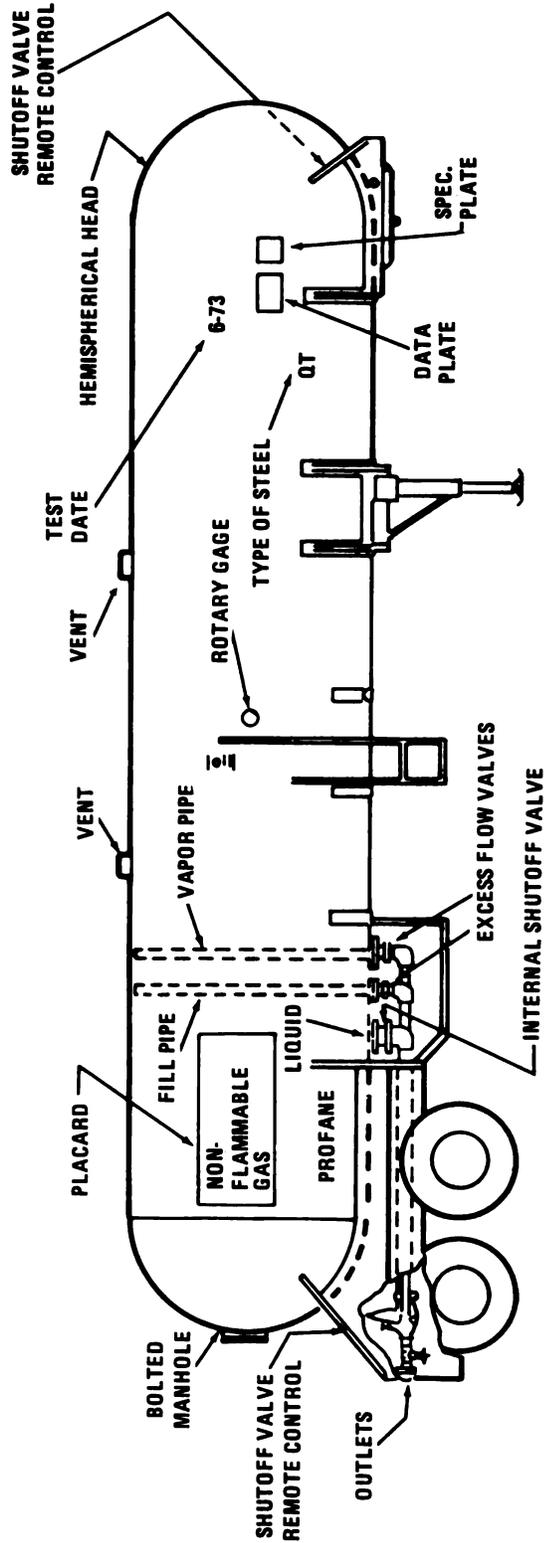
Cargo Tanks. — Title 49 CFR 178 prescribes the minimum packaging for hazardous materials in transportation. The DOT says these requirements are to contain the materials "to withstand conditions normally incident to transportation and minimize the chance of an incident". ^{4/} Title 49 CFR 178.337-11 prescribes emergency discharge controls for MC 331 cargo tanks, such as the one involved in the Houston accident. Emergency discharge controls, which are provided to minimize the possibility of overloading the tank from internal pressure, consisting of two pressure-relief vents, excess-flow valves, and emergency controls, are not effective in case of catastrophic damage to the tank. (See figure 11.)

Figure 11. Inspection guide for MC 331 cargo tank safeguards.

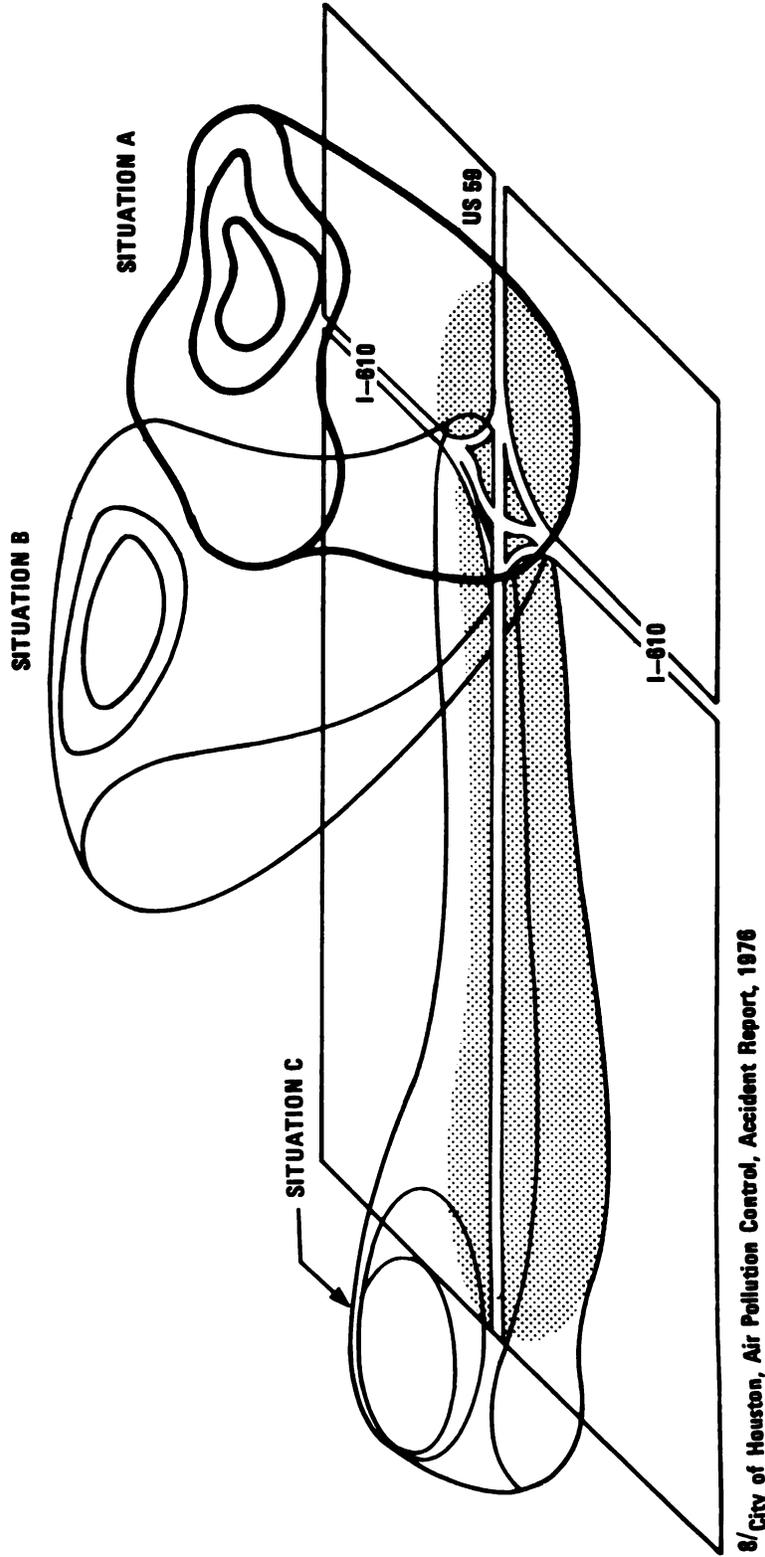
In Houston, the dispersion rate of the released cargo was limited and directed by the meteorological conditions following the puff release. Figure 12 depicts the predicted dispersion of the anhydrous ammonia release in Houston under three different potential meteorological situations. Meteorological conditions at Houston at 11:15 a.m. on May 11, 1976, produced a condition

Figure 12. Artist's concept of the spread of ammonia under three different meteorological situations.

comparable to Situation A, the least harmful dispersion. The Safety Board found examples of "Situation C" in its investigation of the Pensacola accident where a puff traveled more than 9 miles along the surface under a light steady wind, and in its investigation of the Crete accident where a strong temperature inversion at 4° F produced a heavy ground vapor concentration forcing a house-to-house search and evacuation of 200 to 300 persons.
