Ammonia Liquid Leak Incident Case Study

Date Incident Occurred: January 15, 2011 at approximately 7:15 PM

Summary of the Incident

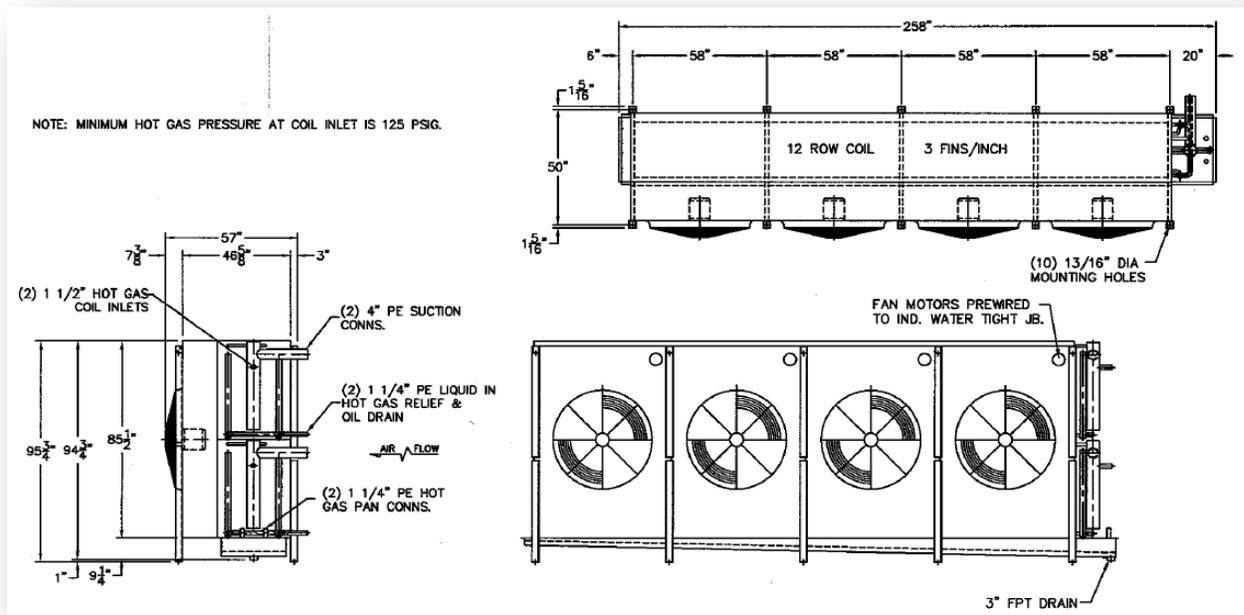
Figure 2: Blast Cell #1 evaporator details.

Refrigeration Operator #2 discovered one of the four fan motors on the evaporator (see Figure 2) had burned out. Because each evaporator has only one electrical disconnect for the entire unit, individual fan motor fuses were sequentially pulled to electrically "disconnect" the failed motor while allowing the three remaining fans to operate so that the blast cell could remain in operation. Log entries did not accurately state what was done to the unit and why fuses were pulled.

During 3rd shift on early morning of January 15, 2011, production personnel notified refrigeration that "noise" was coming from Blast Cell #1. Refrigeration Operator #3 responded and found ice build-up on the shrouds surrounding the fans. The ice was removed and the unit returned to operation. Since the 2nd shift log was inaccurate, 3rd shift personnel were unaware of similar work being performed on the unit earlier in the day.

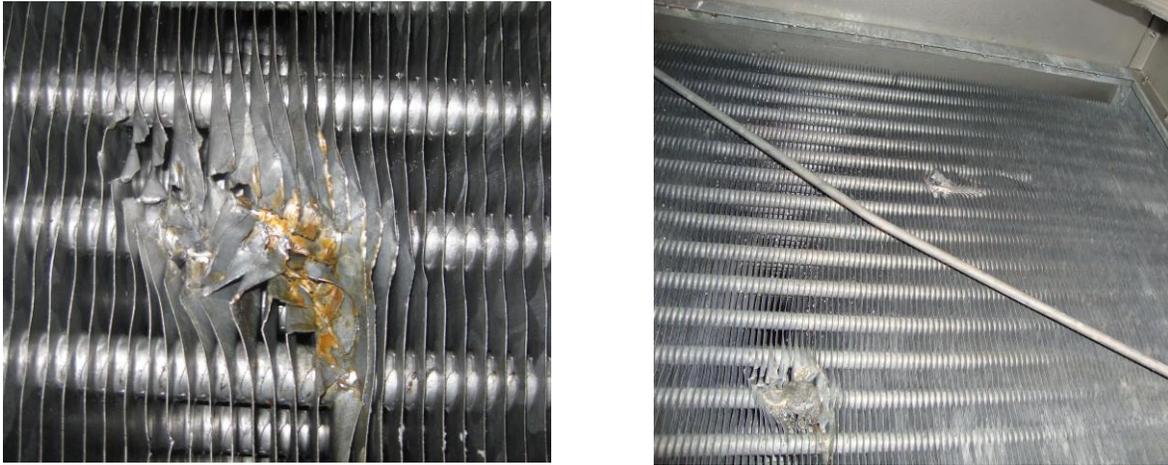
Figure 3: Fan blade impact points on Blast Cell #1 evaporator.

The leak source originated as the result of a loss of mechanical integrity of the **Blast Cell #1** evaporator coil caused by a fan blade on the unit piercing the coil. Figure 3 shows a close-up of one of the coil breaches (left photo) and other fan blade impact points on the coil face (right photo).

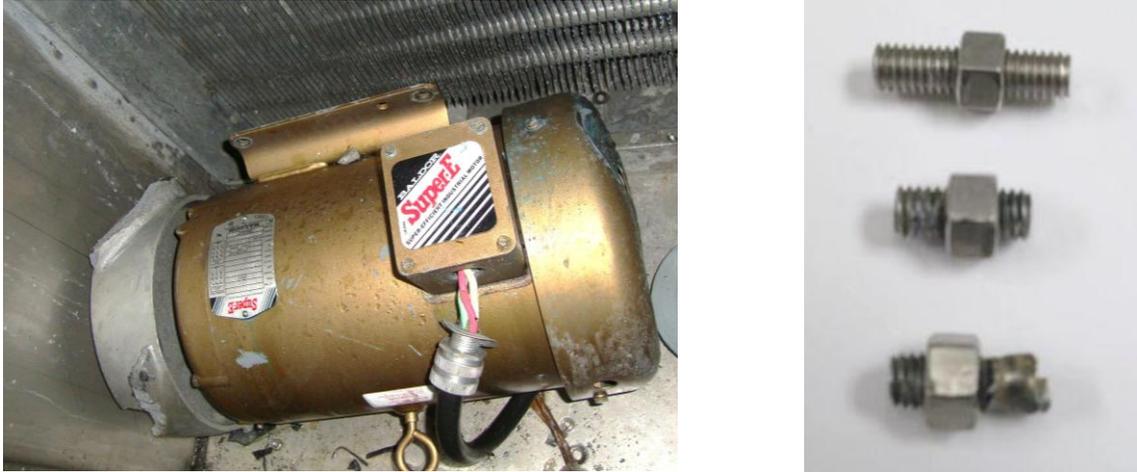
Figure 4: Fan motor mount failure on Blast Cell #1 evaporator.

Chronic and excessive vibration on the unit enabled the motor mount bolts to fail.

The fan blade was allowed access to the evaporator coil because the fan motor mounting bolts catastrophically failed as shown in Figure 4. It is likely that stray ice accumulation contributed to creating fan blade imbalance that was left uncorrected for a period of time. Chronic and excessive vibration caused the fan motor mounting bolts to progressively loosen. Once loose, vibration caused the fan motor mounting plate to progressive cut into the mounting bolts leading to their eventual failure. A post-mortem inspection of other fan motors on the blast cell area evaporators turned up a number of loose mounting bolts and several bolts that had loosened to the point of complete disengagement.

- Replace existing evaporator fan motor mounting hardware with new mounting hardware that is vibration resistant and suitably rated for the operating temperature service. Specifically, consider installing lock nuts on the evaporator fan motor mounting bolts. In addition, ensure that all refrigeration personnel are trained in this change (MOC) including the proper use and installation of the new mounting hardware.

- Install a "ShockWatch³[®]" or similar sort of devices on each blast cell evaporator. This device senses excessive vibration and triggers an alarm notification, automatic shutdown of the evaporator fan, and automatic closure of refrigerant supply valves (liquid feed, hot gas).

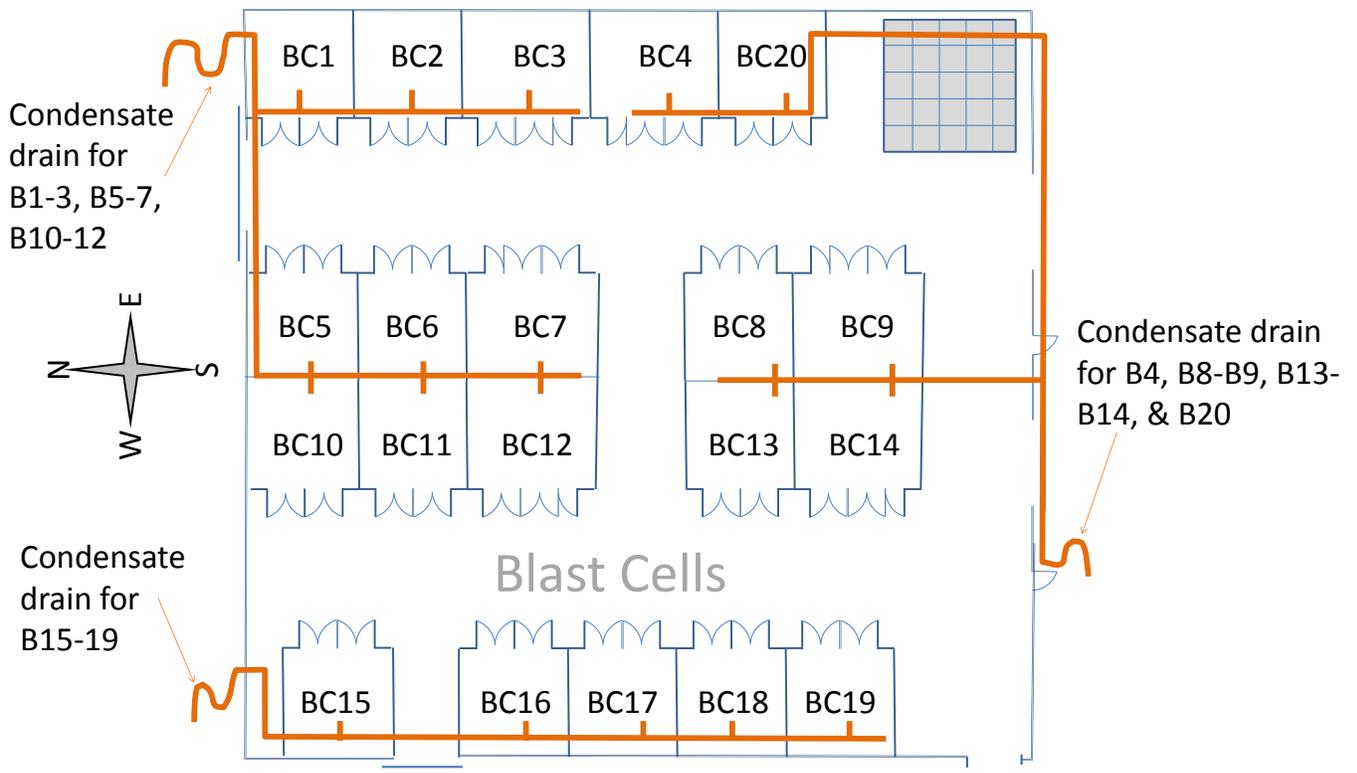
Figure 5: Defrost condensate drain lines for Blast Area.

If the leak originated in Blast Cell #1, how did the ammonia get from Blast Cell #1 to Blast Cell #3. The answer to that question lies in the piping arrangement for defrost condensate for evaporators in the blast cells. Figure 5 shows the layout of defrost condensate piping for each of the blast cells. The condensate pan drain lines for all blast evaporators are ganged together in three drain mains.

Unfortunately, drain connections from individual evaporators are not trapped. The lack of traps allowed ammonia vapor to migrate from Blast Cell #1 to Blast Cell #3 and all the other blast cells connected to that common condensate drain header. The preferred arrangement would be to have each condensate drain header individually trapped and properly heat traced.

- Re-pipe the defrost condensate drain lines so that each individual evaporator is properly trapped. This eliminates the condensate drain path as a conduit for cross-contaminated blast cells containing a leak with those that are leak-free.
