INCIDENT INVESTIGATION REPORT

Date of incident
October 17, 2017

Location of incident
**Fernie Memorial Arena
991 6th Avenue
Fernie, B.C.**

Investigation file number
FSI-REG-2017-0123

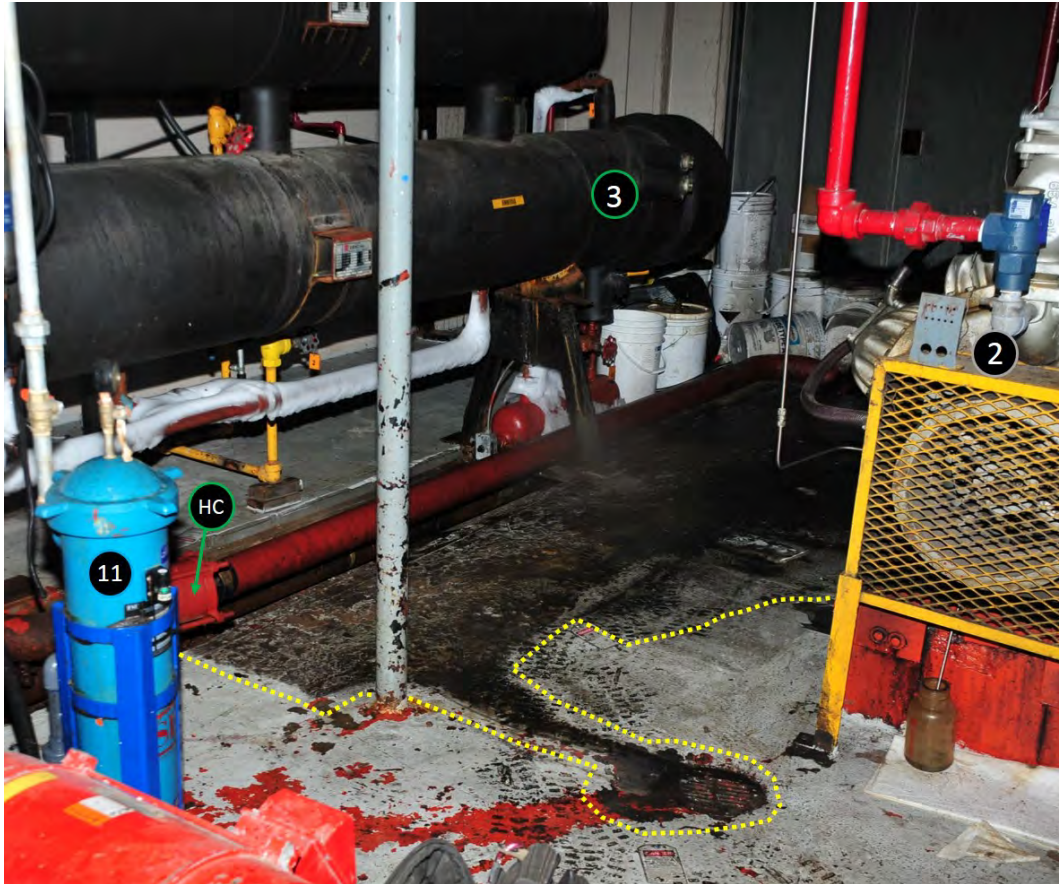
where the curling rink brine outlet pipe had separated. Some of the expelled liquid flowed into floor drains in the compressor room and vestibule. (See Figures 9 and 10.)

Figure 9: The compressor room, looking southeast, showing the brine outlet pipe that separated at HC (horizontal coupling), located under the hockey rink chiller (3). The black, oily liquid that sprayed out of the separated pipe is outlined by the dotted yellow line. Also shown are compressor 2 (2) and the curling rink brine filter (11). (Orange paint is visible through the top coat of grey paint on the concrete floor.) (Source: Ram Environmental Response Ltd.)

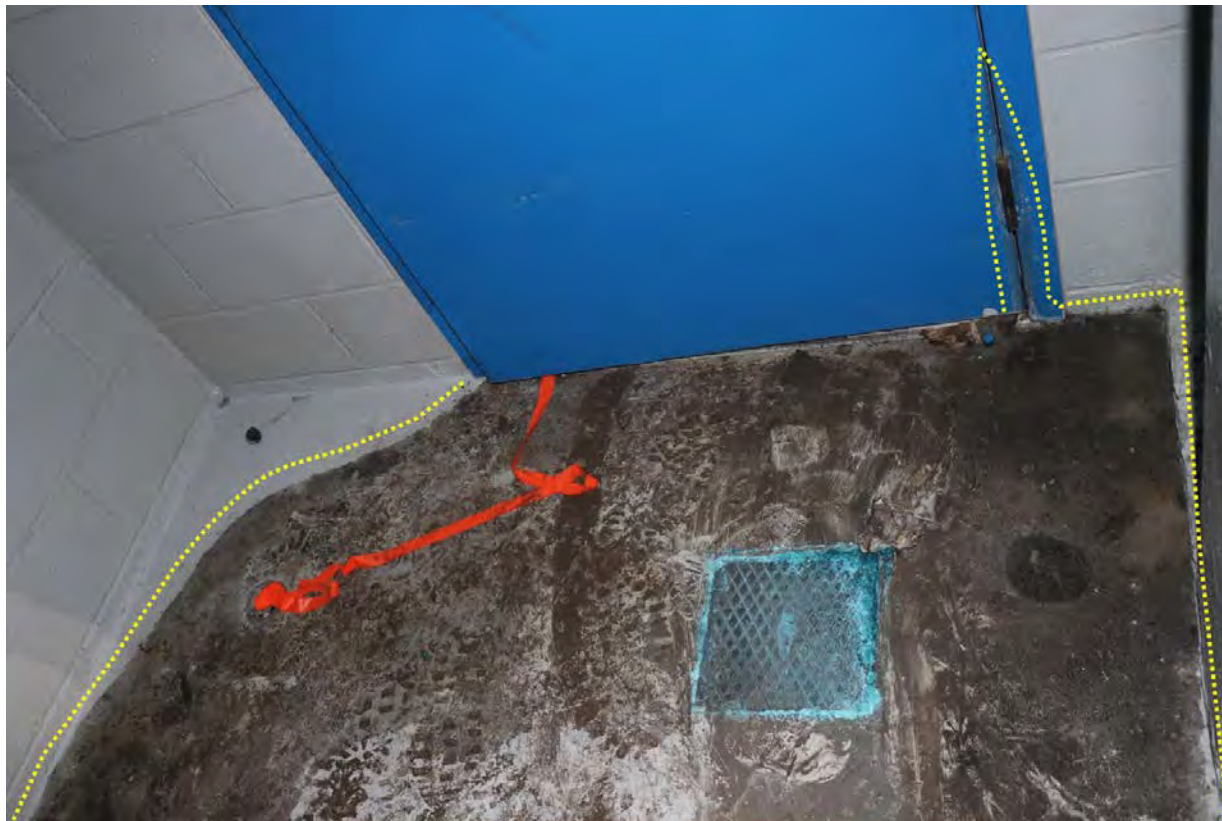
Figure 10: Vestibule floor and door. The oily liquid flowed under the door and through the hinge area. The blue colour on the brass floor plate indicates exposure to ammonia.

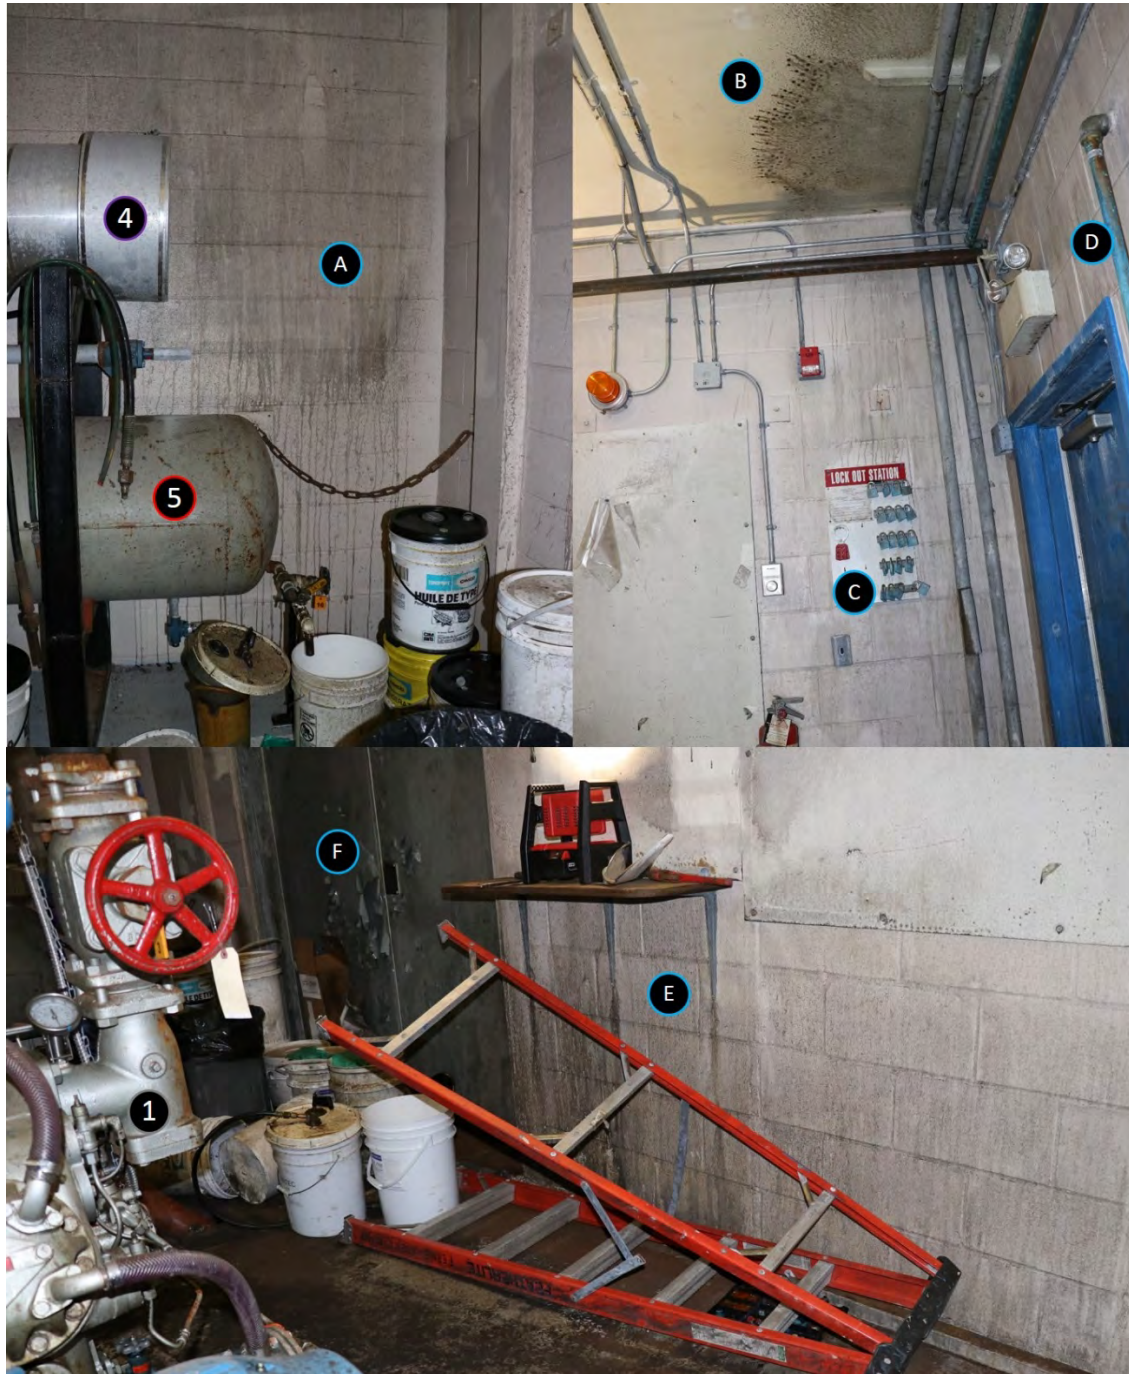
The spray of black, oily liquid in the compressor room was confined to the west side of the room and was observed to be vectored from the separated pipe to the west wall. Spray patterns on the ceiling and walls suggest that there was significant volume and pressure involved when the liquid was deposited on the interior surfaces of the compressor room. (See Figure 11.)

Figure 11: Composite images of the compressor room, showing spray patterns from the separated pipe: Spray on the south wall (A) behind the end of the curling rink chiller (4) and receiver (5) and on the ceiling above the vestibule door at the north corner (B). The brass locks (C) and copper pipe (D) turned blue due to ammonia exposure. Behind compressor 1 (1) is spray and pooling of black liquid on the west wall and floor (E). The paint peeled off the sealed double door (F) after exposure to the ammonia-brine mixture.

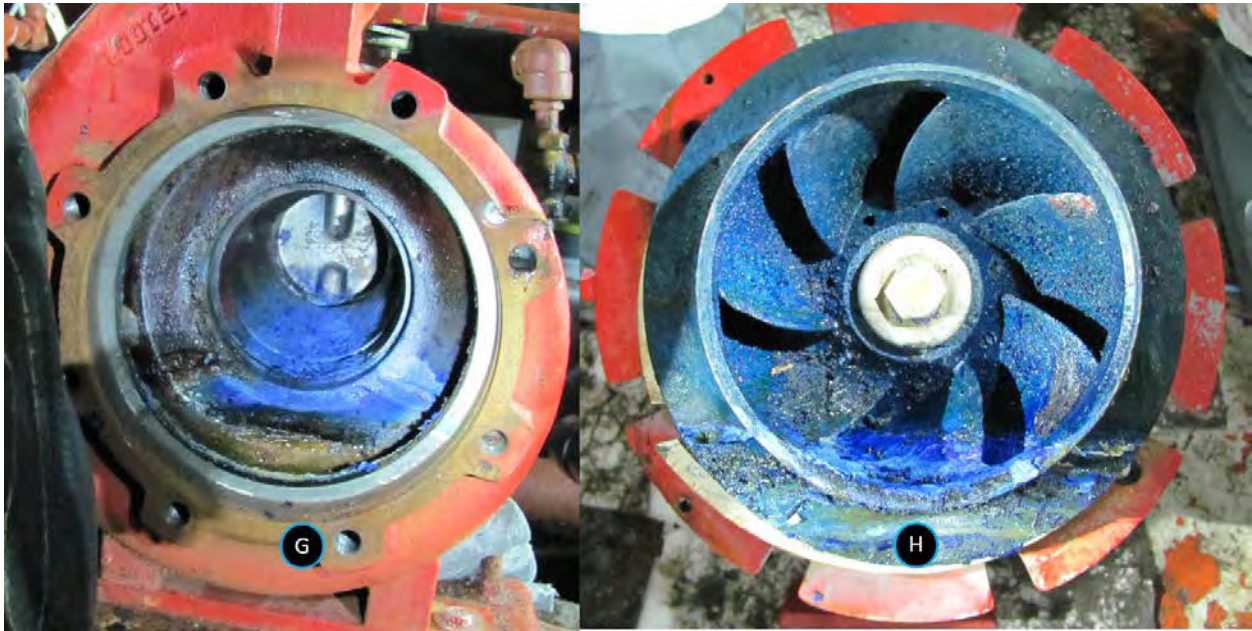
All three of the brine circulation pumps were leak-checked, disassembled, and examined at the incident site. No foreign material, broken machine parts, or other obstruction was observed that would prevent any of the brine pumps from operating as intended. It was observed that the curling rink brine loop piping materials that contained copper or zinc alloys had reacted unfavourably from exposure with the ammonia-brine mixture, causing noticeable corrosion or discoloration. This effect was quite pronounced on the copper alloy/bronze impeller for the curling rink brine pump but was not observed on the other two brine pumps, which were isolated from the curling rink chiller. (See Figure 12.)

Figure 12: The interior of the curling rink brine pump housing (G) and the pump impeller (H), showing the corrosive effect of ammonia to some metals in the system, in this case the copper alloy/bronze pump impeller.

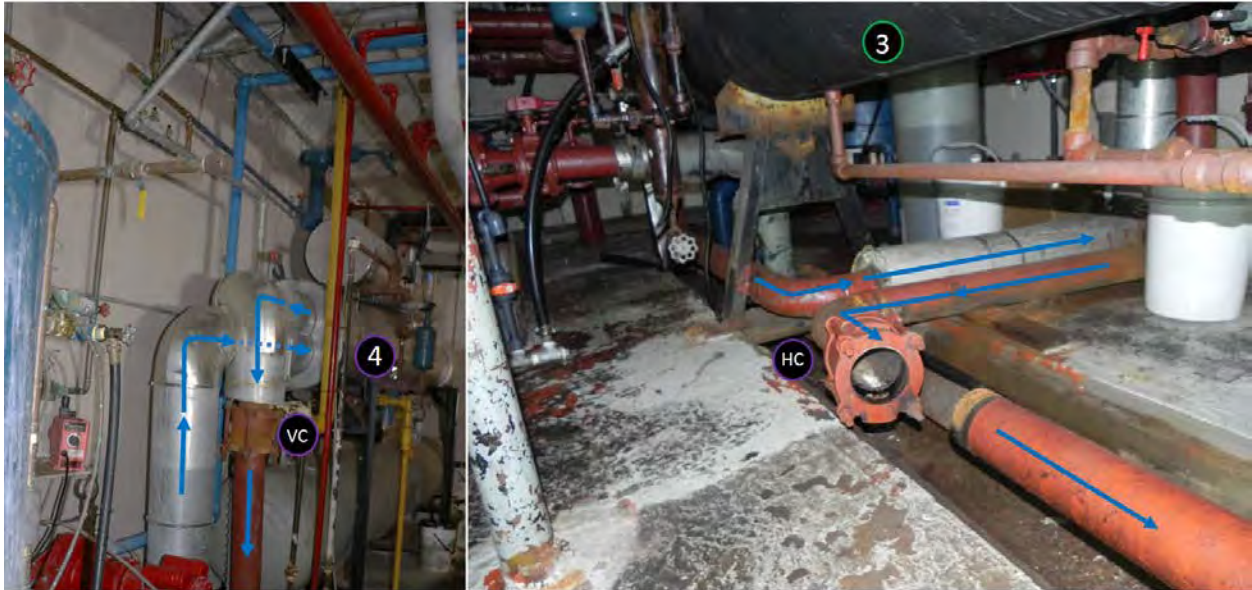
All of the brine piping was comprised predominately of schedule 40 steel pipes at diameters between 4 and 6 inches. All of the flanges and joints were welded or bolted connections with the exception of the 4-inch-diameter curling rink brine outlet pipe. At this location, two connections were made using bolted, sleeve-type couplings. One connection was mounted in a vertical position (VC in this report), and the other was mounted horizontally (HC in this report). The pipe that separated at the time of the incident did so at the HC joint. (See Figure 13.)

Figure 13: The photograph on the left shows the position of the vertical coupling (VC) on the brine outlet pipe of the curling rink chiller (4). The photograph on the right shows the horizontal coupling (HC) under the hockey rink chiller (3) and downstream of the VC. The normal brine circulation path is indicated by the blue arrows.

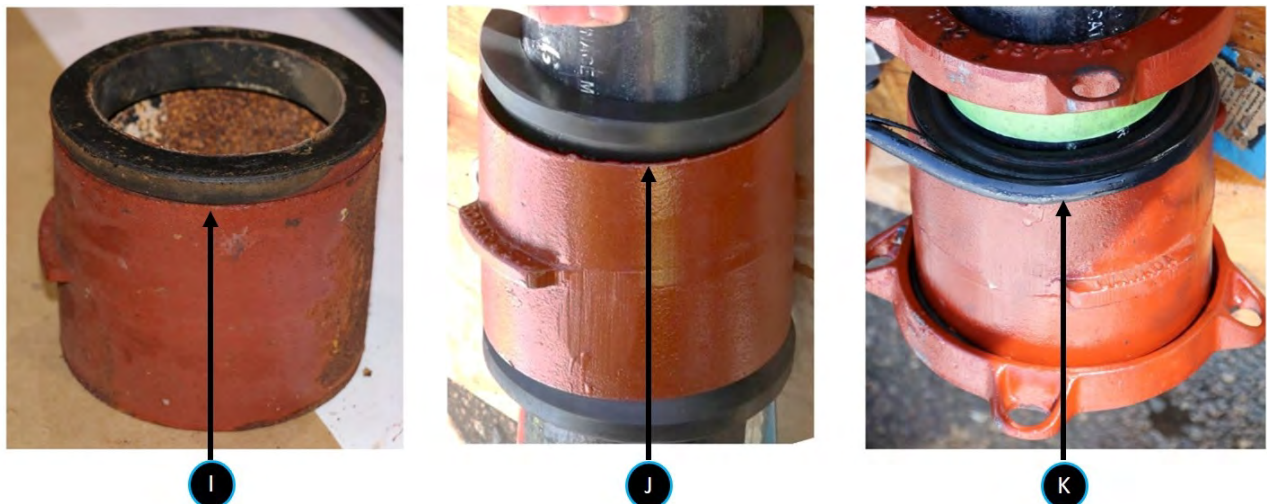
The VC and HC from the compressor room were also disassembled. WorkSafeBC investigators observed that the gasket face from the HC assembly removed from the compressor room did not have the same identifiable pattern impression and more closely resembled the new, uninstalled gasket from the pipe coupling exemplar. (See Figure 14.)

Figure 14: The HC gasket face as found in the compressor room (I); the new, uninstalled gasket face at the same location on the pipe coupling exemplar (J); and the new gasket less than one hour after being installed as per the manufacturer’s instructions (K).

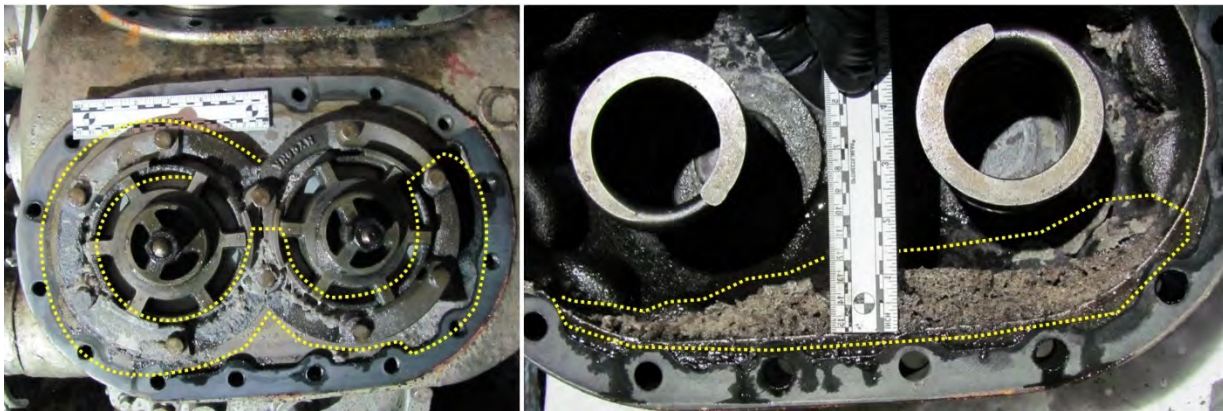
Each compressor has eight cylinders, located in four banks of two. When the cylinder head covers were removed, substantial crystal growth could be observed in both compressors. (See Figure 15.) The crystalline growth was indicative of brine infiltration into the compressor cylinders, which is an abnormal operating condition. The ammonia gas compressors are not designed to handle any liquid. There was no mechanical connection of the ammonia gas compressors to the brine system. As such, inadvertent misdirection of brine into the ammonia gas compressors should not be possible.

Figure 15: Crystal accumulation (yellow outline) in the ammonia gas compressor cylinder heads, showing cylinder heads on the left and a cylinder head cover and springs on the right.

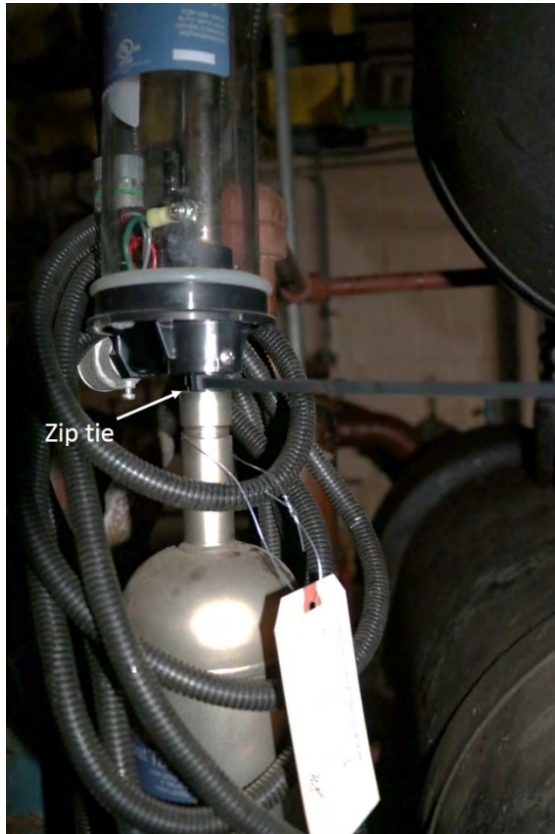
Laboratory results determined that the hockey rink liquid level control was functional, but the ammonia liquid high-level shutdown switch had been defeated by a plastic zip tie and therefore was not functional at the time of the incident. This meant that the entire ammonia pressure shell for the hockey rink chiller could have been filled with ammonia liquid when the chiller was in operation. (See Figure 16.)

Figure 16: Photograph showing a black plastic zip tie used to defeat the factory setting on the ammonia liquid high-level shutdown switch on the hockey rink chiller.

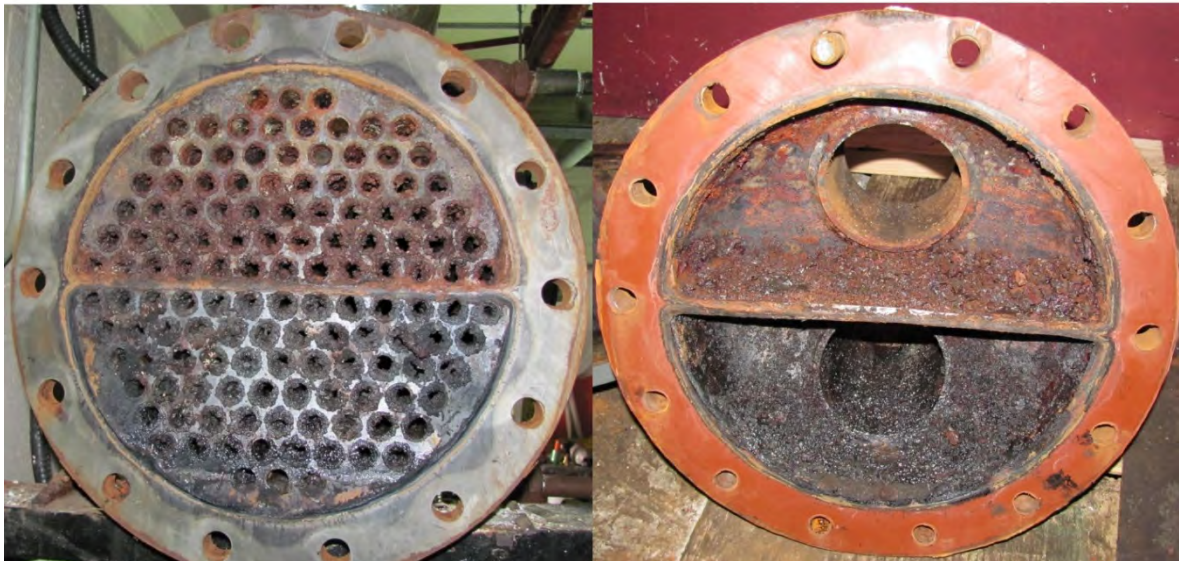
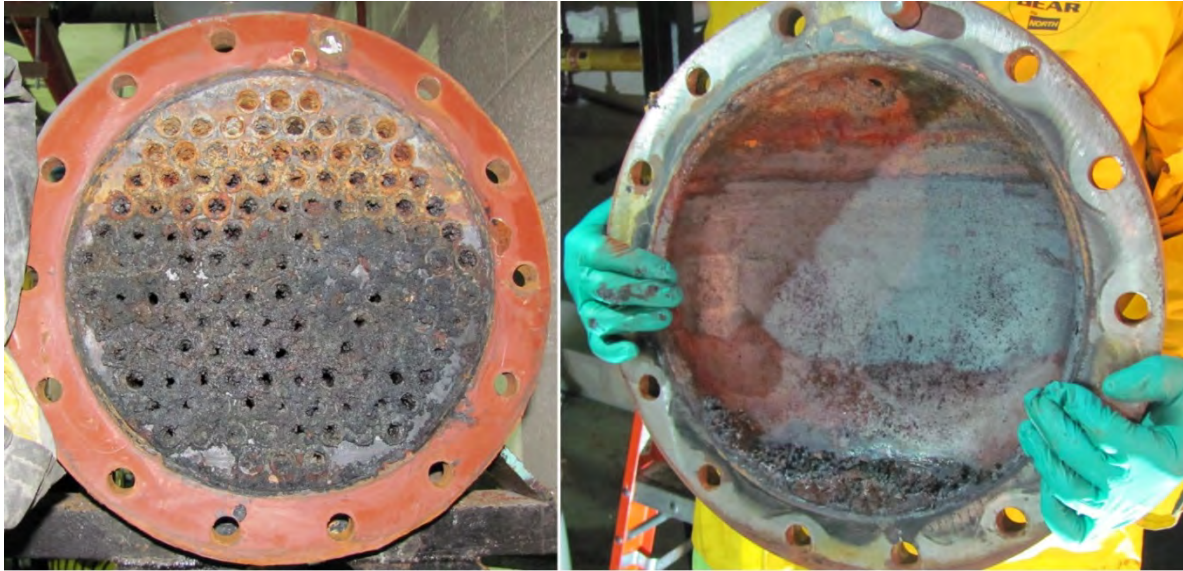
Examination of the tube sheet ends showed a substantial buildup of black, oily liquid. (See Figures 19 and 20.) This residue was determined to be the same as the liquid that had been found sprayed around the west end of the compressor room, where the brine outlet pipe had separated. The accumulation of black liquid was more pronounced in the lower hemisphere of the curling rink chiller than the top hemisphere. In some cases, the brine tubes appeared to be completely blocked, which may have reduced the efficiency of the heat exchange process in the chiller when it was in operation.

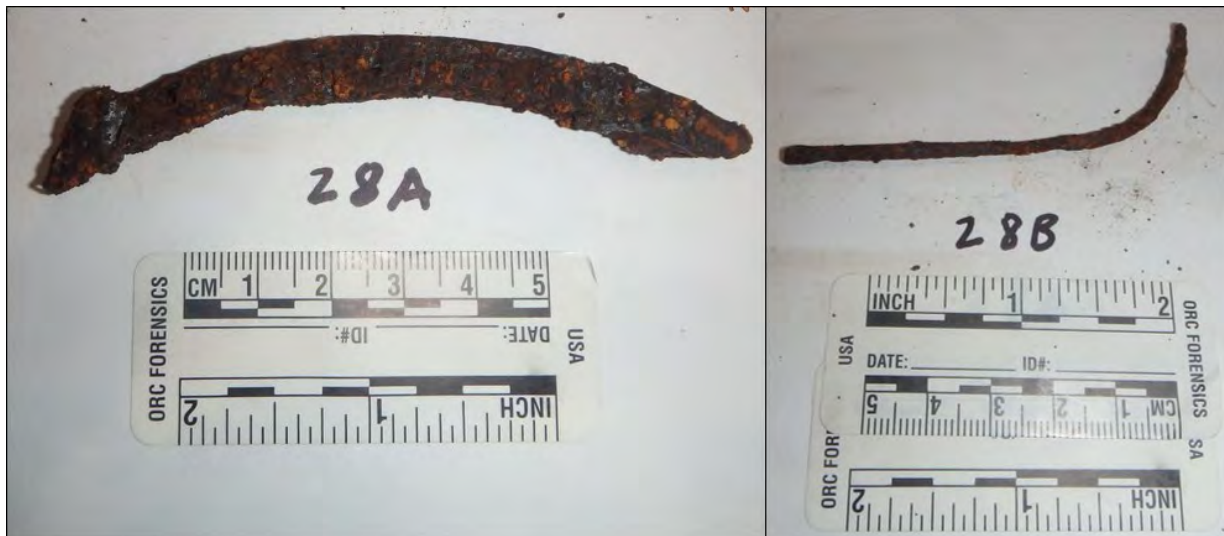
In addition to the black liquid, two pieces of metal were found to be embedded at the inlet end of the brine tube sheet. (See Figure 21.) Laboratory testing determined that the metal parts were a piece of metal (labelled 28A) with the same chemical content consistent with ASTM A53 grade B pipe and a piece of malleable wire (labelled 28B) with the same metallurgical properties as MIG-type welding wire.

Figure 21: Two metal pieces found at the inlet end of the curling rink brine tube sheet.
(Source: Forensic Engineering Report from Acuren Group Inc. — Appendix C)

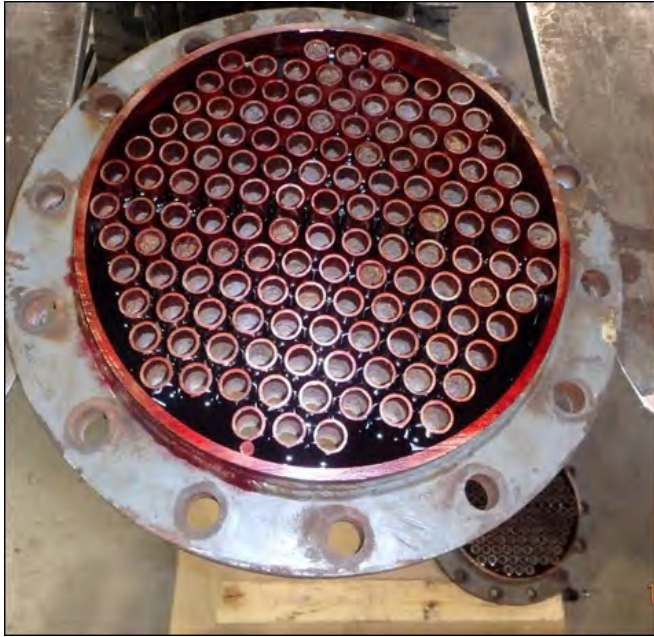
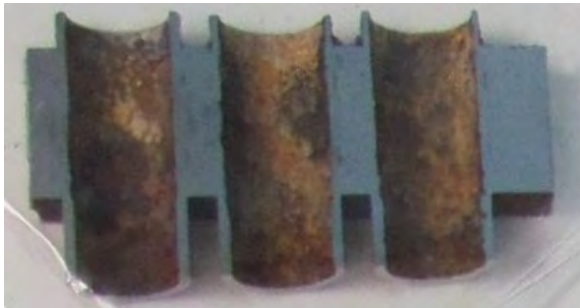
The end plates were removed from both ends of the tube bundle. Leak tests using penetrating dye determined that no leaks were present where the tubes were mechanically joined to the tube sheet plates. The tube sheet plates were cross-sectioned at the mechanical rolled joints. No manufacturing error or leaks were detected at these locations. (See Figures 22 and 23.)

Figure 23: Three brine tubes cross-sectioned at the tube plate. Examination showed good mechanical connection of the rolled tubes with no evidence of leaking.

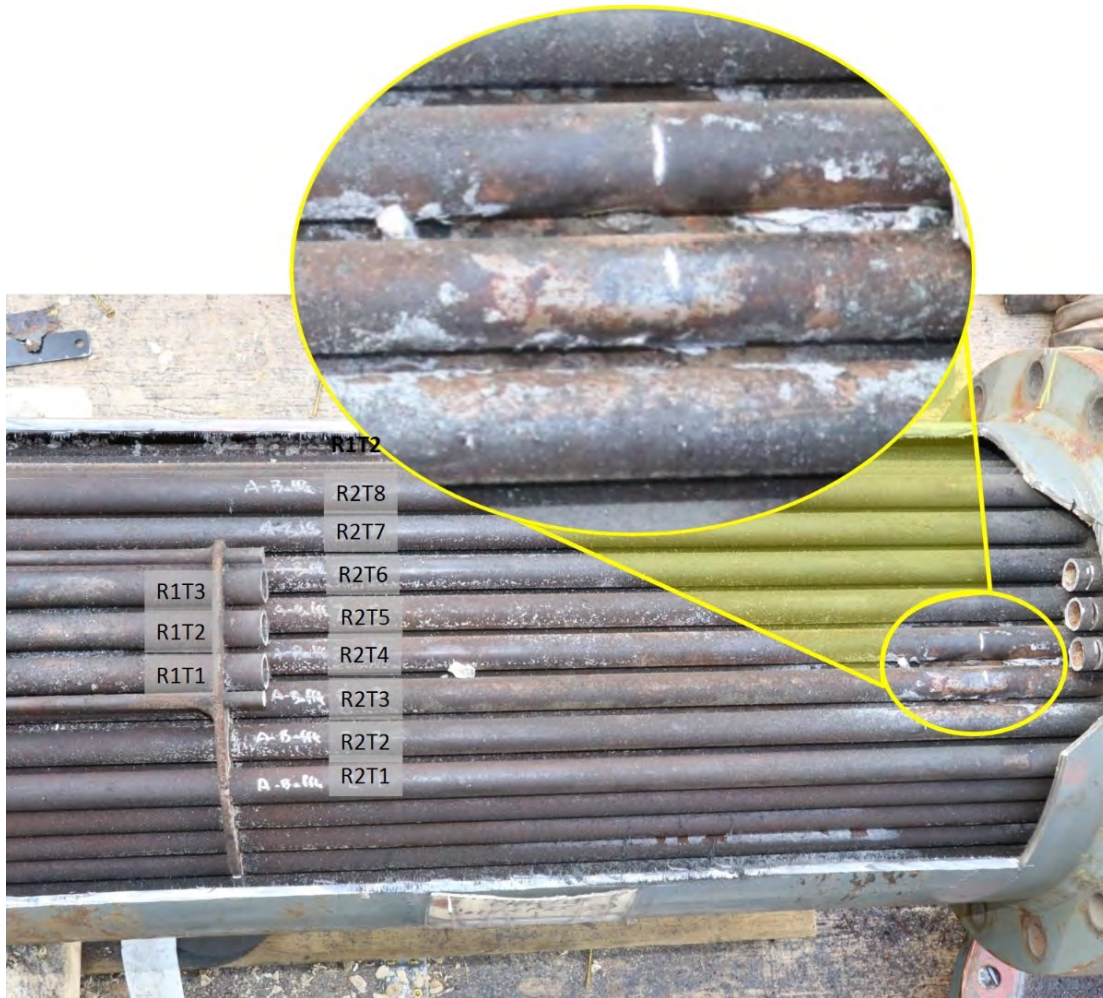
Investigators observed unusual corrosion patterns that appeared to originate from the third tube of the second row. (See Figure 24.)

Figure 24: Photograph with close-up showing radial patterns and corrosion in the second row of brine tubes at the outlet end of the curling rink chiller.

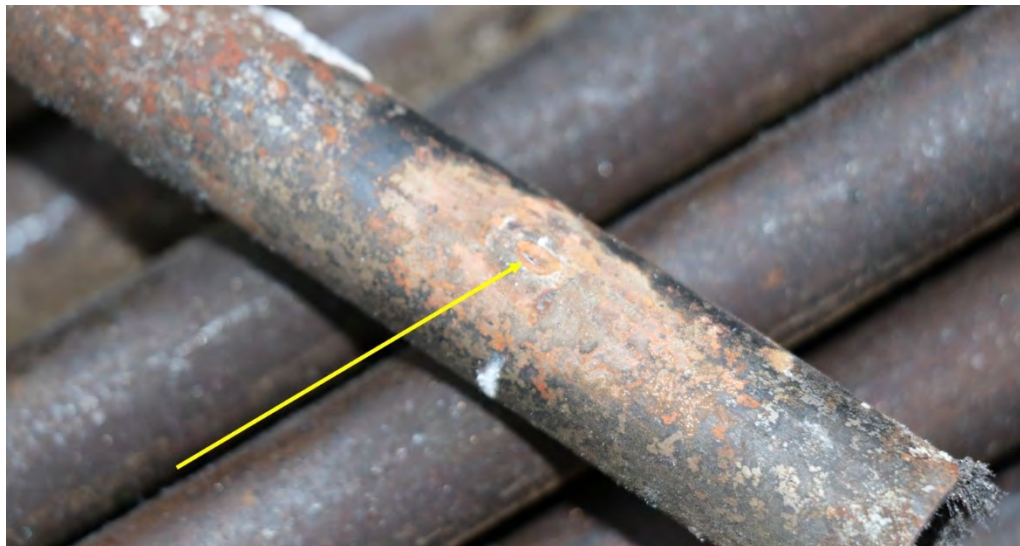
Figure 25: Photograph showing brine tube R2T3 after removal from the tube bundle. WorkSafeBC investigators observed a small hole in the tube (yellow arrow).

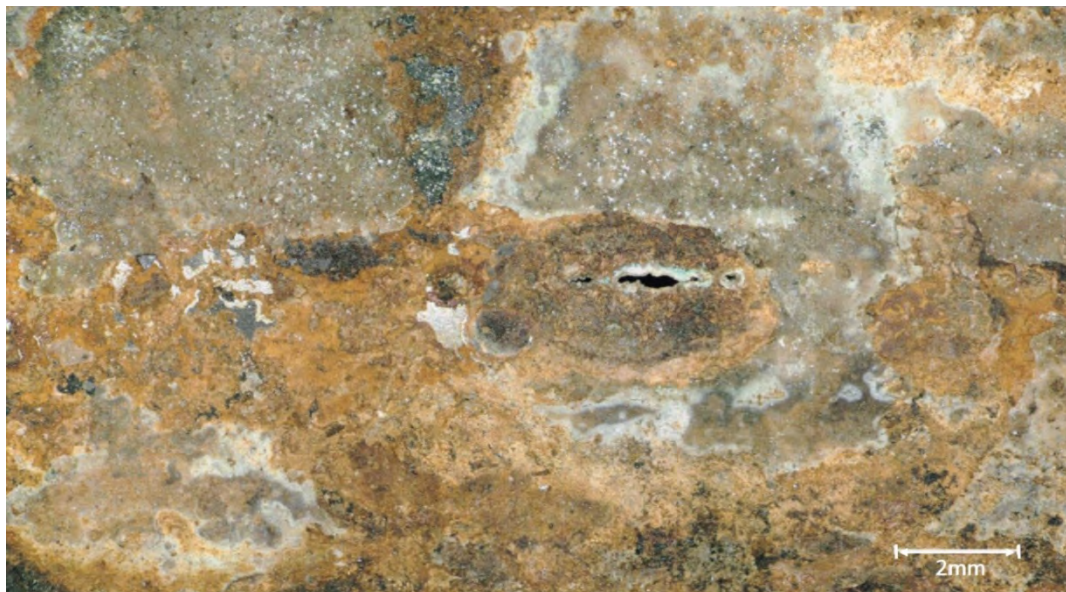
Tube R2T3 was extensively examined. (See Appendix C: Forensic Engineering Report — Acuren Group Inc.) The breach was characterized by a series of corrosion holes comprising an oval-shaped area approximately 2.2 millimetres in length. (See Figure 26.) The entire volume of ammonia that led to the deaths of the three workers in this case can be attributed to the loss of containment of the ammonia through this relatively tiny hole.

Figure 26: Close-up of the exterior of tube R2T3, showing the hole that allowed ammonia to enter the brine circulation system.
(Source: Forensic Engineering Report from Acuren Group Inc. — Appendix C)

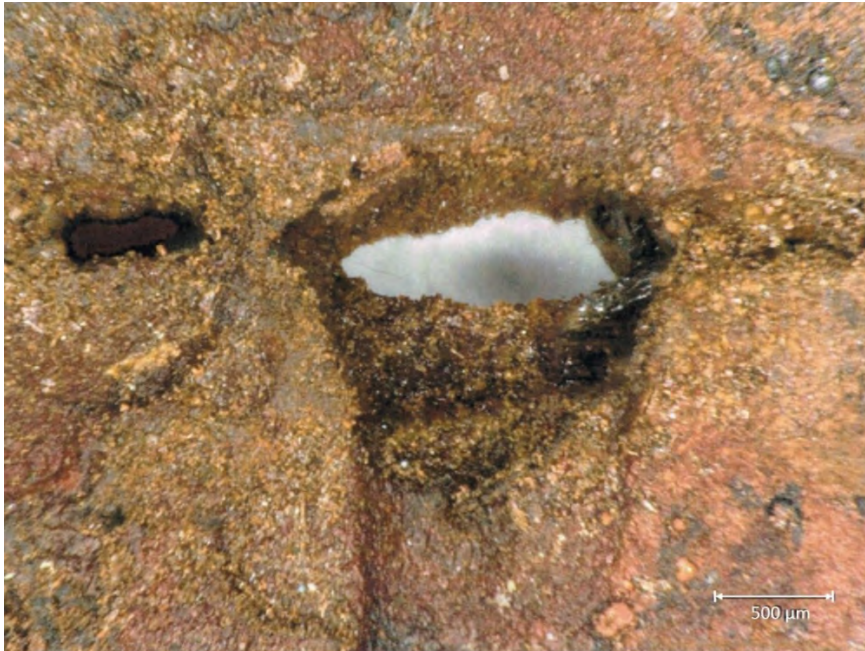
Analysis conducted at the forensic testing laboratory determined that the breach in tube R2T3 was orientated at the 4 o'clock position on the tube, and began on the brine side (inside) of the tube and progressed outward. (See Figure 27.)

Figure 27: Close-up of the hole from the inside of brine tube R2T3. Scouring from the flow/jetting of material into the brine tube can be seen directly below the hole. Other pits have developed on both sides of the breach.
(Source: Forensic Engineering Report from Acuren Group Inc. — Appendix C)

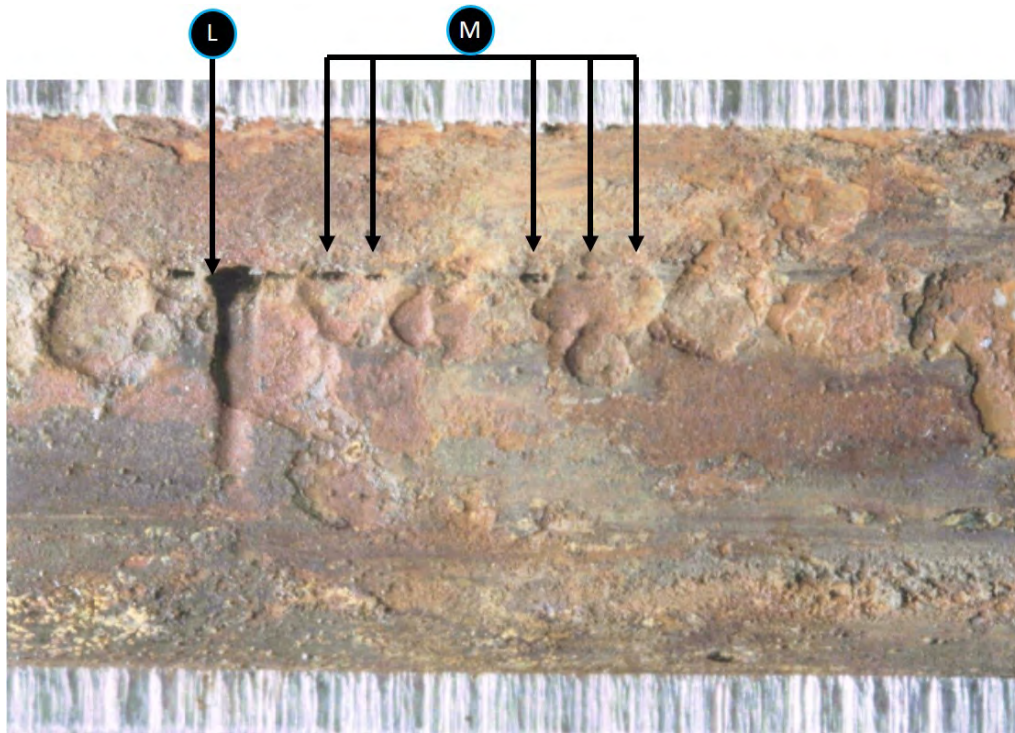
Prior to the creation of the breach, a series of small corrosion holes, or pits, had developed. The pits were of varying depths and had formed in a near-perfect straight line along the length of the tube. The holes were also arranged in groups, so that the line of corrosion presented a pattern similar to stitches made by a sewing machine, or a zipper. (See Figure 28.) This type of pitting is referred to as *preferential corrosion* in this report.

Figure 28: Interior view of brine tube R2T3 after it was cut horizontally. The breach hole (L) is aligned horizontally with other pits that have not corroded all the way through the brine tube (M). (Source: Forensic Engineering Report from Acuren Group Inc. — Appendix C)

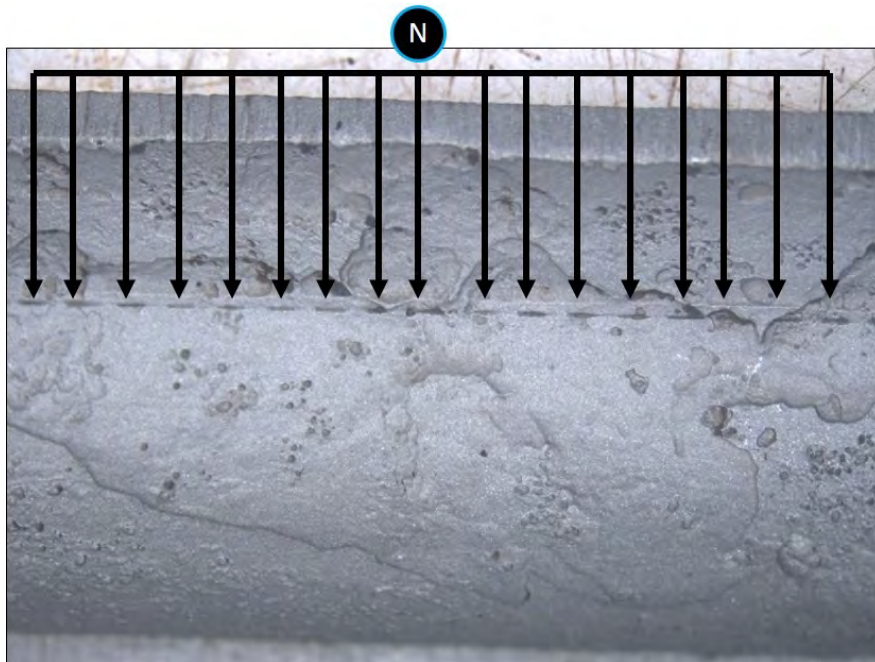
The same effect was also observed in other tubes from the curling rink chiller. The line of pitting was not orientated in any specific direction relating to their installation position in the tube bundle (that is, top, bottom, left, or right). Instead, the pitting was observed to be aligned along the length of each tube, at the seam welding for the tubes. (See Figure 29.)

Figure 29: Interior of a different brine tube (R4T1) after it was cut horizontally and cleaned. A distinctive line of corrosion pits can be seen along the length of the tube interior (N).
(Source: Forensic Engineering Report from Acuren Group Inc. — Appendix C)

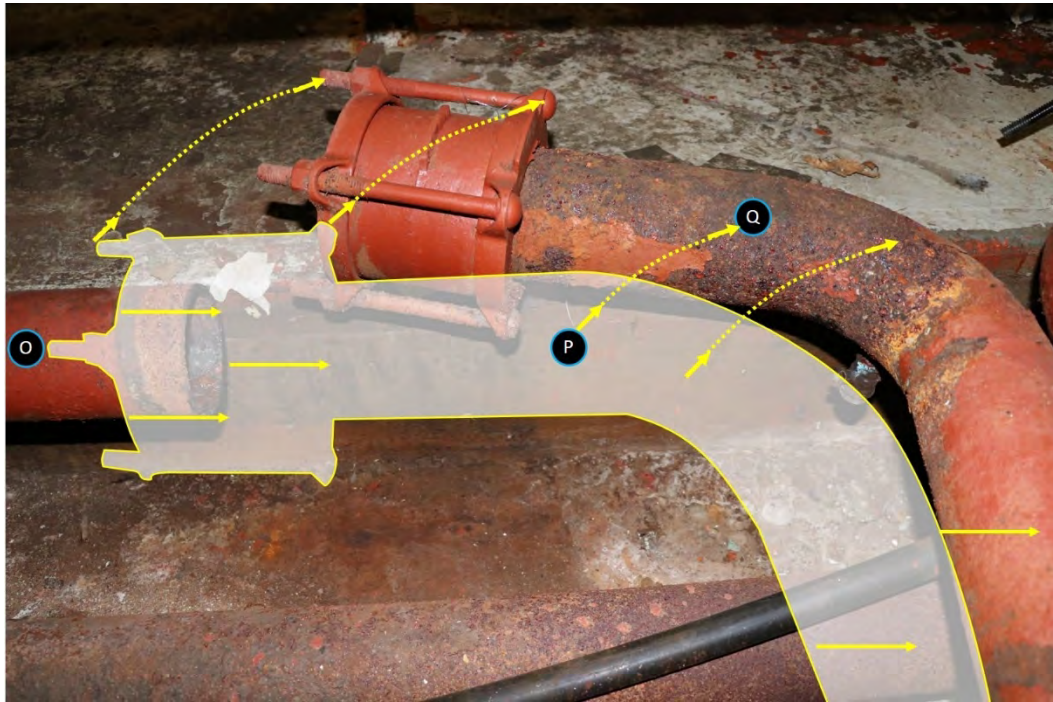
Figure 30: The separated HC fitting on the curling rink brine outlet pipe. The pipe separated because the process of ammonia leaking into the brine developed more pressure than the piping system was able to contain. The pipe section on the left side of the photograph (O) was embedded in the concrete slab and remained stationary. The HC and attached pipe section (P) were unrestrained. When the pressure increased, the HC and pipe section were able to move backward and rotate out of position substantially (Q), as observed by WorkSafeBC investigators after the event.
