Investigation report

Report title Investigation – work accident with ammonia exposure – Naturkraft	Activity number 032000001
--	------------------------------

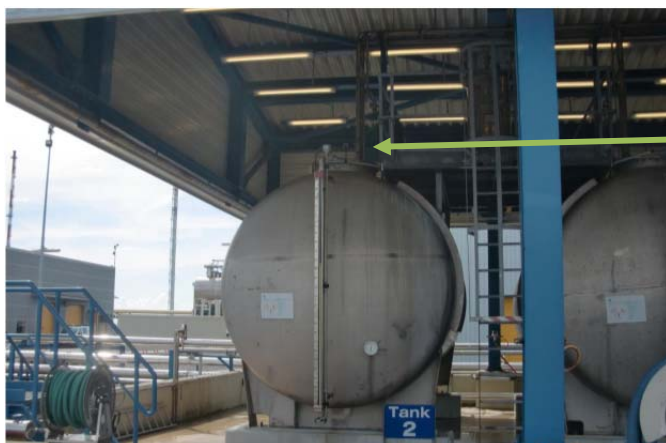
Work location

The job was to be done by two people. One was to act as safety guard, since the work would be done outside the railings on the landing between the ammonia tanks, and safety harness would be worn. The WP prescribes the use of gastight goggles and gas masks during the work. That applied to the person replacing the valve, but not to the safety guard.

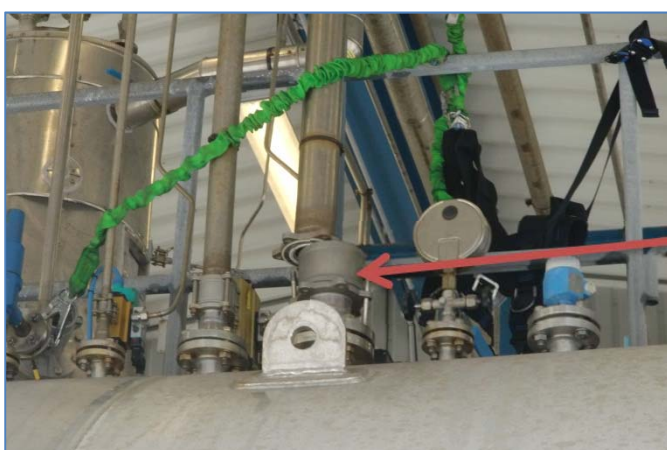
Valve to be replaced

The direct cause of this leak was that the tank had an overpressure of 0.25 bar. Since the filling line descended some distance into the liquid in the tank, the pressure acted on the liquid so that ammonia solution ascended through the piping and emerged from the flange when this was broken.

Removing the actuator and opening the valve manually to drain ammonia solution from the pipe to the tank were the initial steps. Work continued once the team heard the draindown cease. They discovered that the bolts on the valve had not been fully tightened. Tightening these did not stop the leak, and it was decided to replace the valve. The safety guard continued to ready equipment and tools up on the landing, while the other person went out onto the tank and started disassembly. As soon as the bolts had been loosened, ammonia solution began to spurt out between the valve and the pipe flange. The person working on disassembly out on the tank stood up and turned away from the chemical spray, which was so powerful that his whole body became covered. Ammonia solution penetrated behind his goggles and beneath his gas mask, and he accordingly tore these off. He managed to get over the railings, out of the safety harness, across to the ladder and down from the landing. On reaching the emergency shower, he began to remove his clothes. The emergency shower quickly lost water pressure, and the person ran to the office building and the changing room shower. At the same time, he notified the ammonia leak. This had already been detected by the line detectors at the edge of the area. The point detectors over the tanks had been overridden, so they sounded an alarm in the control room but initiated no action in the plant.

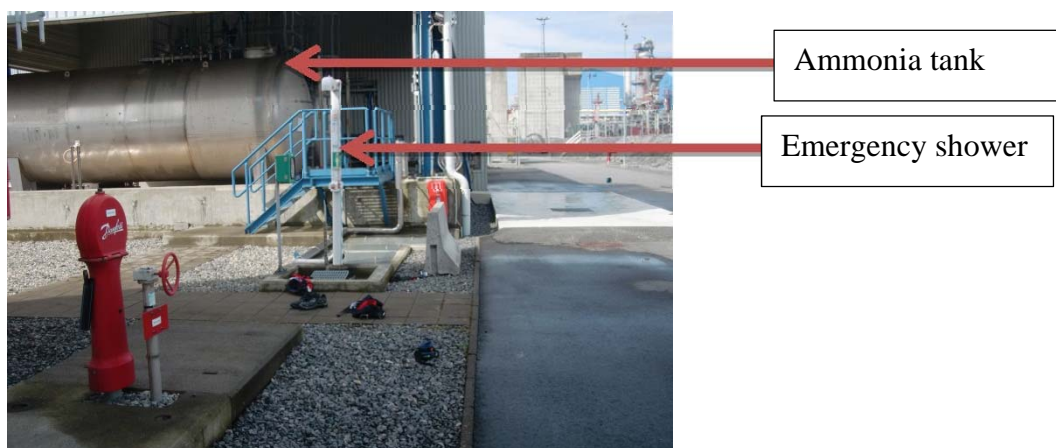
When the alarm sounded, the person who had worked on the valve came running in and reported where the accident had happened. Two people then ran out to assist the safety guard. Their search for him took them partly through the gas cloud. They found the guard quickly behind the tank building and helped him to the changing room.
