# Ammonia Tank Failure—South Africa

Detailed report on a major disaster in a fertilizer plant that took 18 lives, with a discussion of investigation results, and commentary on safety policies.

H. Lonsdale  
AE & CI Ltd.  
Natal, South Africa

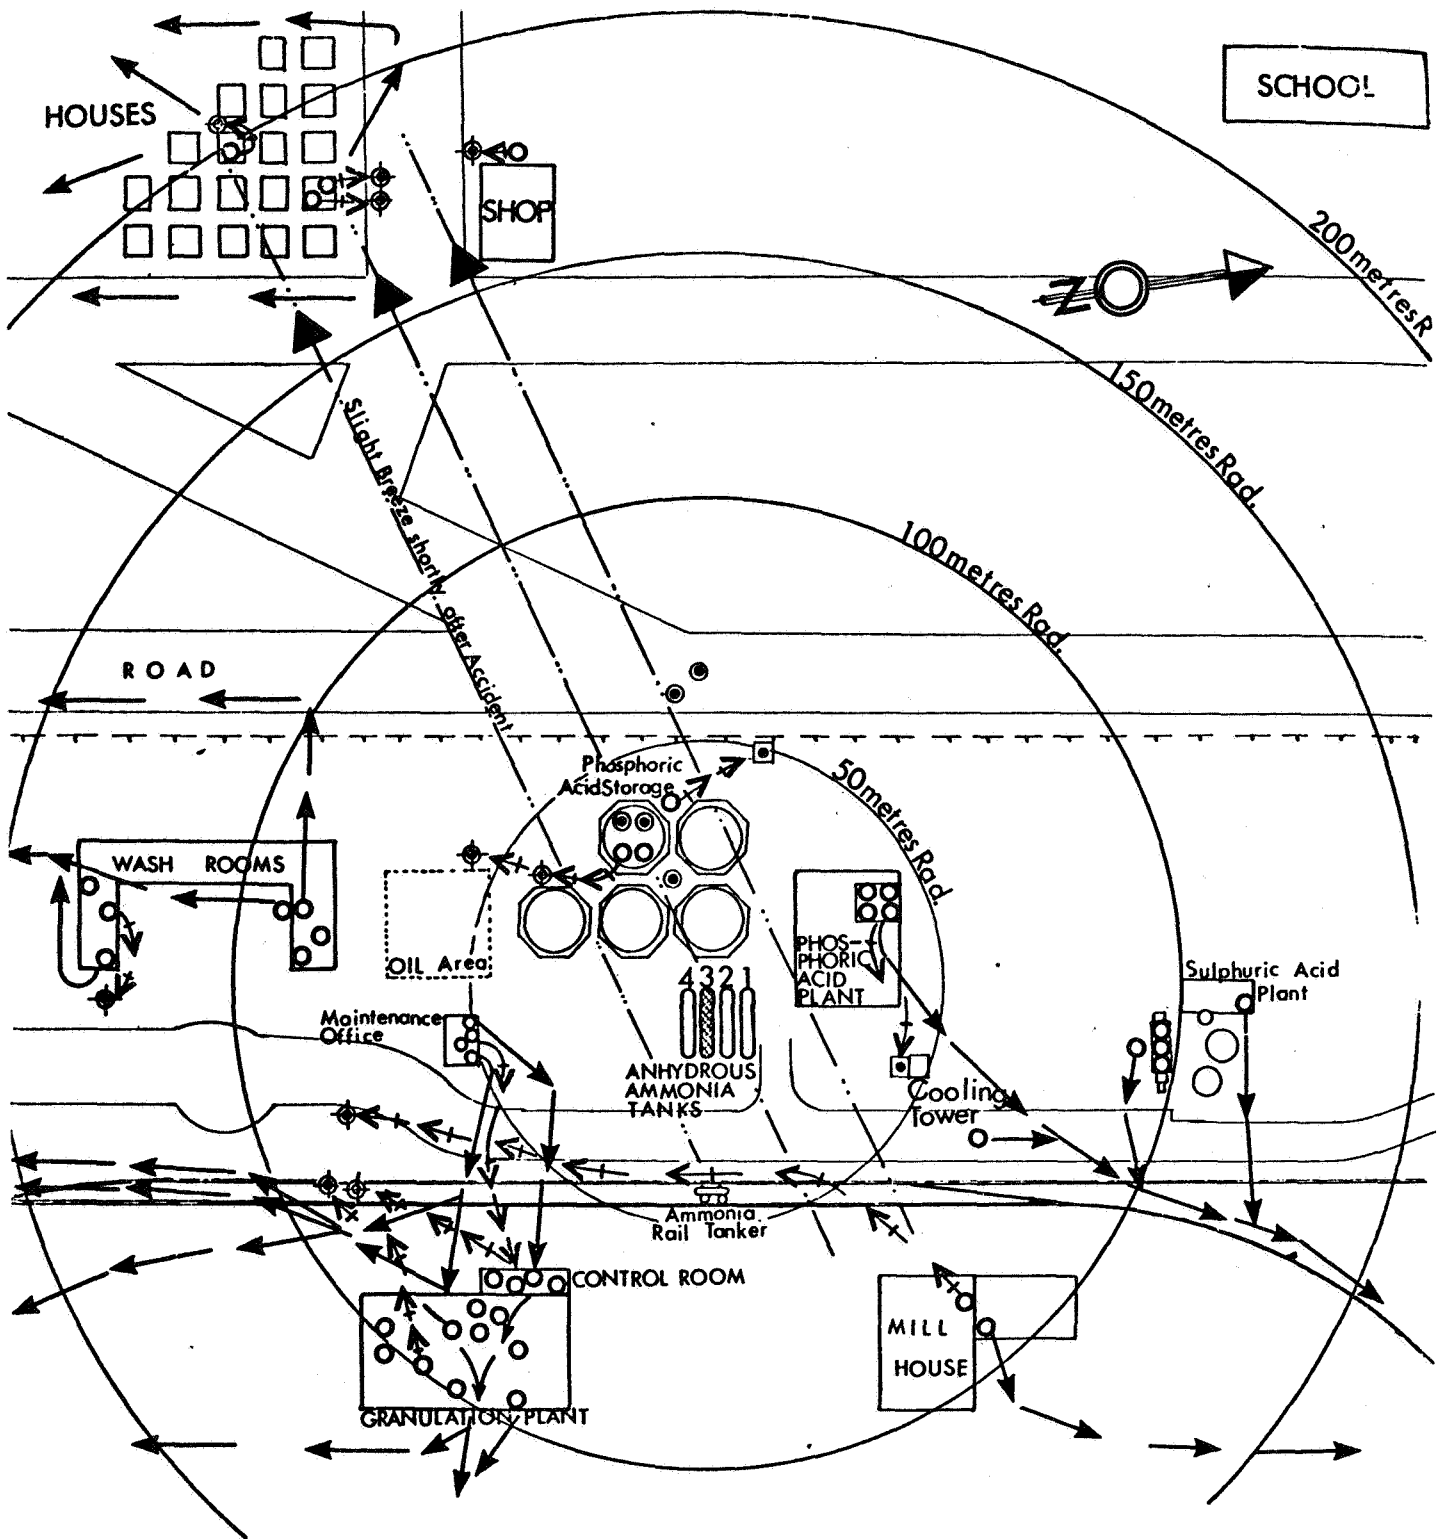
Figure 1. General layout of Potchefstroom plant.

All personnel in the direct line of the blast (to the west as seen in Figure 1) eventually died. Two of these men had been able to climb out of a storage tank, 30 m. from the failure, and run 25 m. before collapsing. Those working on the phosphoric acid plant 40 m. to the north of the failure all escaped except one who had just had pneumonia. There was a report of breathable air near the plant's cooling tower.

Offloading equipment was in good order and procedure was in accordance with standard practice. The piping arrangement was such that two storage tanks (Nos. 3 and 4 in Figure 1) were being filled simultaneously. The pressure in the receiving tanks was noted to be 90 lb./sq.in. gauge approximately two minutes before the failure.

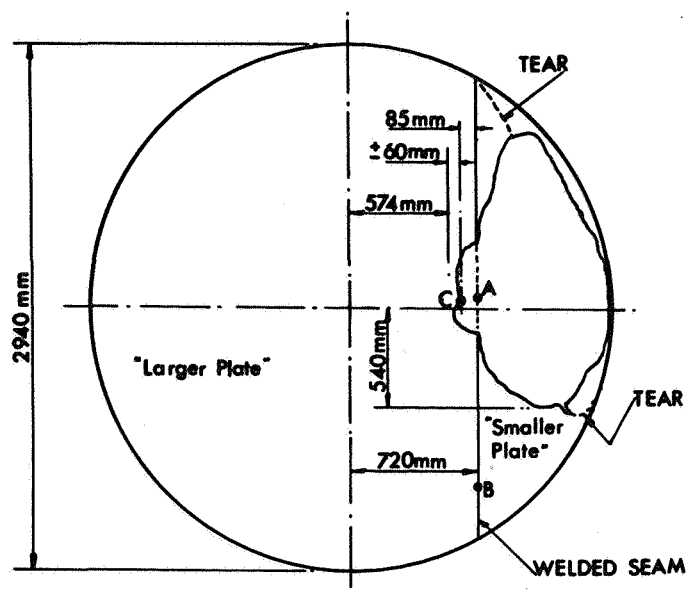
Figure 2. View on outside of dished end.

One seam weld fault was ground out and repaired satisfactorily. The other, indicated as A in Figure 2, was considered to be lack of side wall fusion or slag entrapment 3/16-in. deep and 3/4-in. long. It was ground out and rewelded at least twice before being passed. Radiographs then showed a new crack 1-1/2-in. from the repair and 4-in. long: this was also ground out and rewelded. The report on this repair mentions some piping and porosity, but no further repairs were attempted. The final repair zone was some 8-in. long.

The west dished end of No. 3 tank failed in an explosive manner. The mild steel vessel measured 2.9 m. diameter x 14.3 m. long. The fracture propagated from the larger of the two plates making up the dished end (Point C in Figure 2), but mainly involved the smaller plate. The fracture progressed all around the main repair area but did not start in the welded seam. The broken-out section, equal approximately to one quarter the area of the dished end, was propelled a distance of 40 m., including two changes of direction after striking the ground and rupturing an acid tank.

Regarding crack initiation the larger plate of the dished end was extremely brittle, having a transition temperature of 115°C in both directions. It was considered that the crack was initiated in this plate at a point directly adjacent to the weld repair and about 2-in. away. Chevron patterns on both sides pointed in that direction. The source of the crack was not positively identified. Crack propagation tended to be diverted, or actually stopped, by the seam weld.

1. Stress-relieving should have been carried out on the dished ends, the completed vessel, and after the 1971 weld repairs at Potchefstroom.

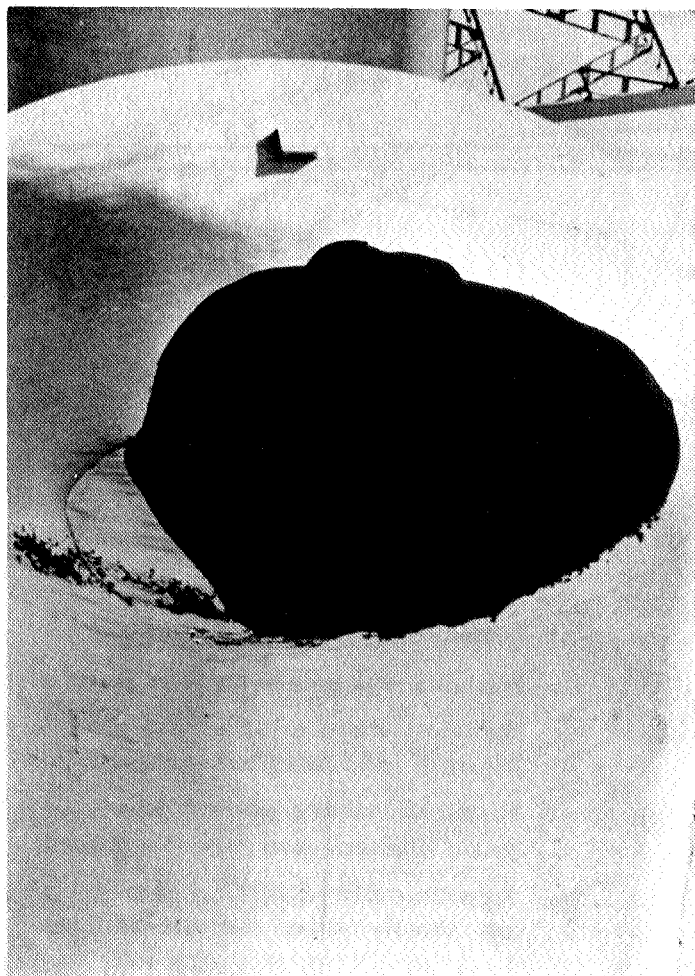
Figure 3. Close-up photograph of rupture in dished end.

The photograph in Figure 3 shows the rupture. Figure 4 is a general view.

1. The failure was mainly in the smaller plate, although the broken-out section included a short length of seam weld and part of the larger plate.

2. There was no sign that deformation or thinning of the plates had occurred. The steel had fractured in a brittle manner.

3. The length of seam weld in the broken-out section included the major repair zone.

4. Chevron markings were readily seen in the fracture surface.

6. There were branching-off tears at the top and bottom of the main break. The mating surfaces of these fractures were however also brittle in appearance.

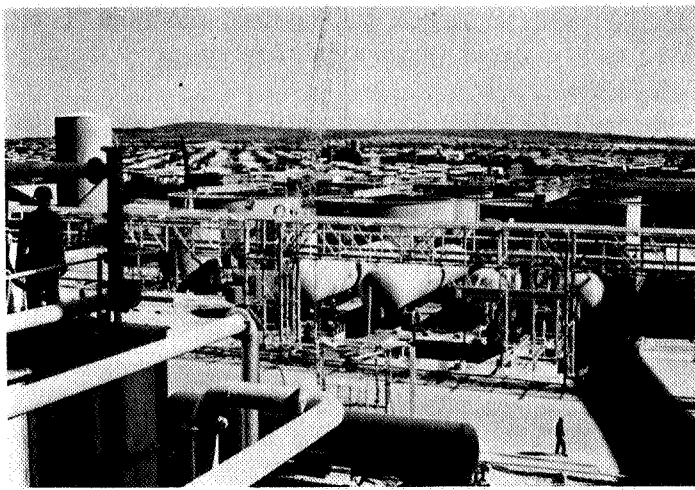
Figure 4. View of the ammonia tanks, looking west in direction of ammonia cloud drift. Replacements for Nos. 3 and 4 tanks are seen in position.
