Accident Report

Ammonia Leak

San Nikunau

REPORT NO.: 05 3749

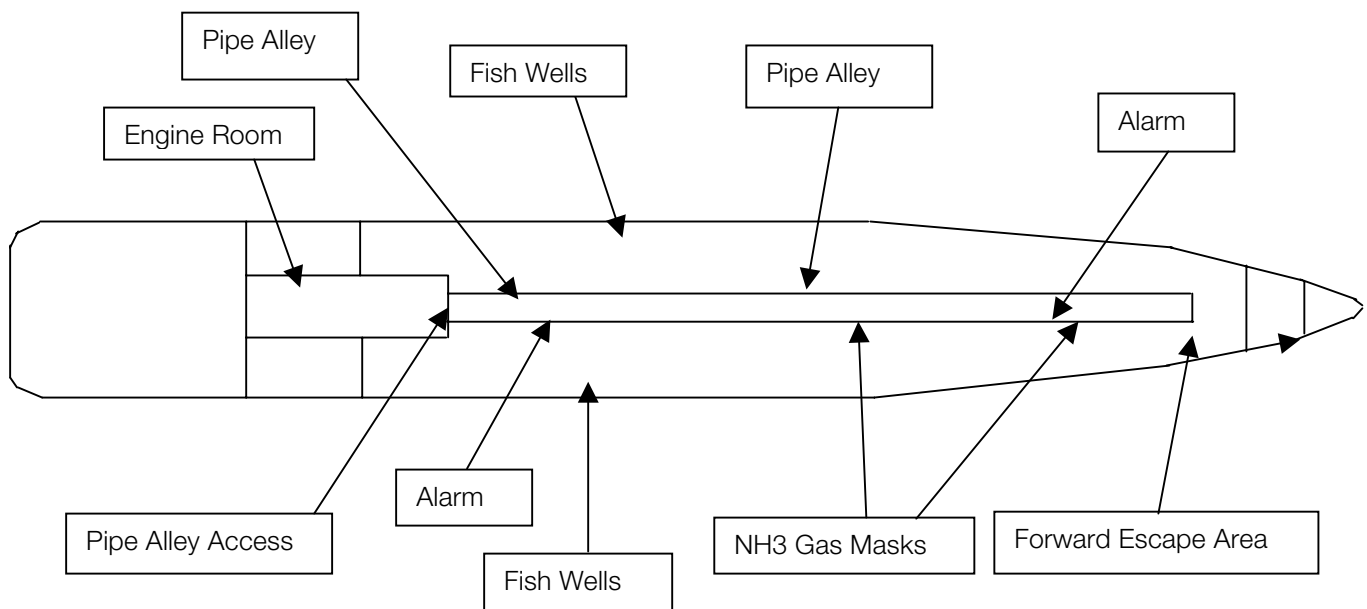
Figure 1
San Nikunau – Below Maindeck Diagram
(not to scale)

The pipe alley runs along the duct keel from the engine room to the No. 1 fish well in the bow section. Access to the pipe alley is from the engine room. At the forward end there is an escape exit up onto the main deck. A catwalk running the full length of the alley separates it to an upper and lower section. Three receiver units in the alley contain ammonia for refrigerating fish wells. Each unit is capable of holding 1500 litres. During operation, one unit is kept in reserve. At the time of the accident the units were at 75% capacity. The pipe that failed was on the port side of the catwalk behind large condenser pipes. Heavy rust was found at the section that failed. Behind the bulkheads on both sides of the alley are fish wells (See Figures 1 & 2 - Diagram of below main deck and refrigeration system (not to scale) plus photograph of pipe alley from position of leak)

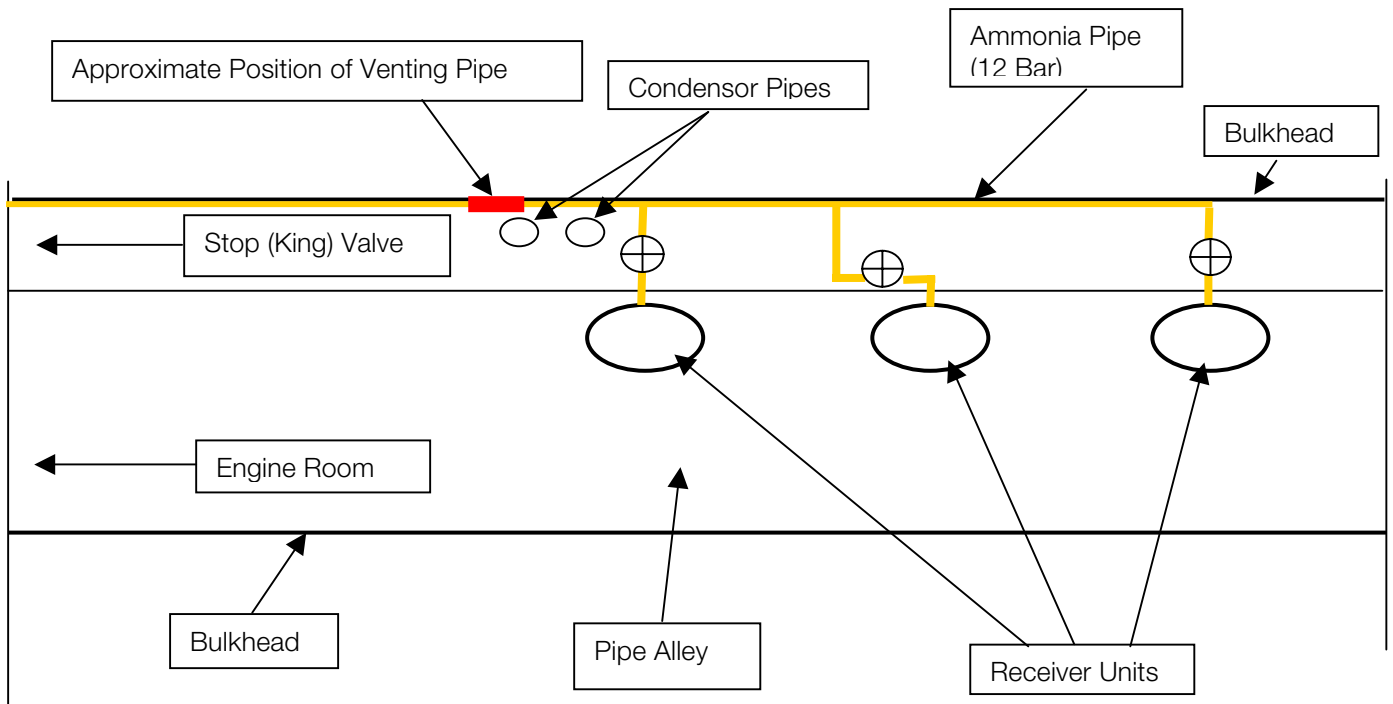
Figure 2
 Section of Pipe Alley where Ammonia was vented
(not to scale)

Shortly before 0215 hours, three crew including the Chief Engineer, were working in the pipe alley to reduce brine temperatures when a small ammonia gas leak was detected from a rusted section of the discharge line from the receiver. The Chief Engineer instructed the Assistant Engineer and Oiler to close valves to isolate the section of pipe whilst he went under the catwalk to check for further leaks. As the valves were being closed, but before the pipe could be isolated, it commenced venting a large quantity of ammonia. The Engineer ordered the crew to evacuate the pipe alley. As he left, he closed the king valves, however, the discharge continued as the venting pipe was not fully isolated. The two crew who were forward of the leak escaped by running aft, through the venting ammonia, and in so doing sustained ammonia burns to their legs and arms. (See Figures 1 & 2 - Photographs of the pipe alley showing area where ammonia vented & pipe that failed).

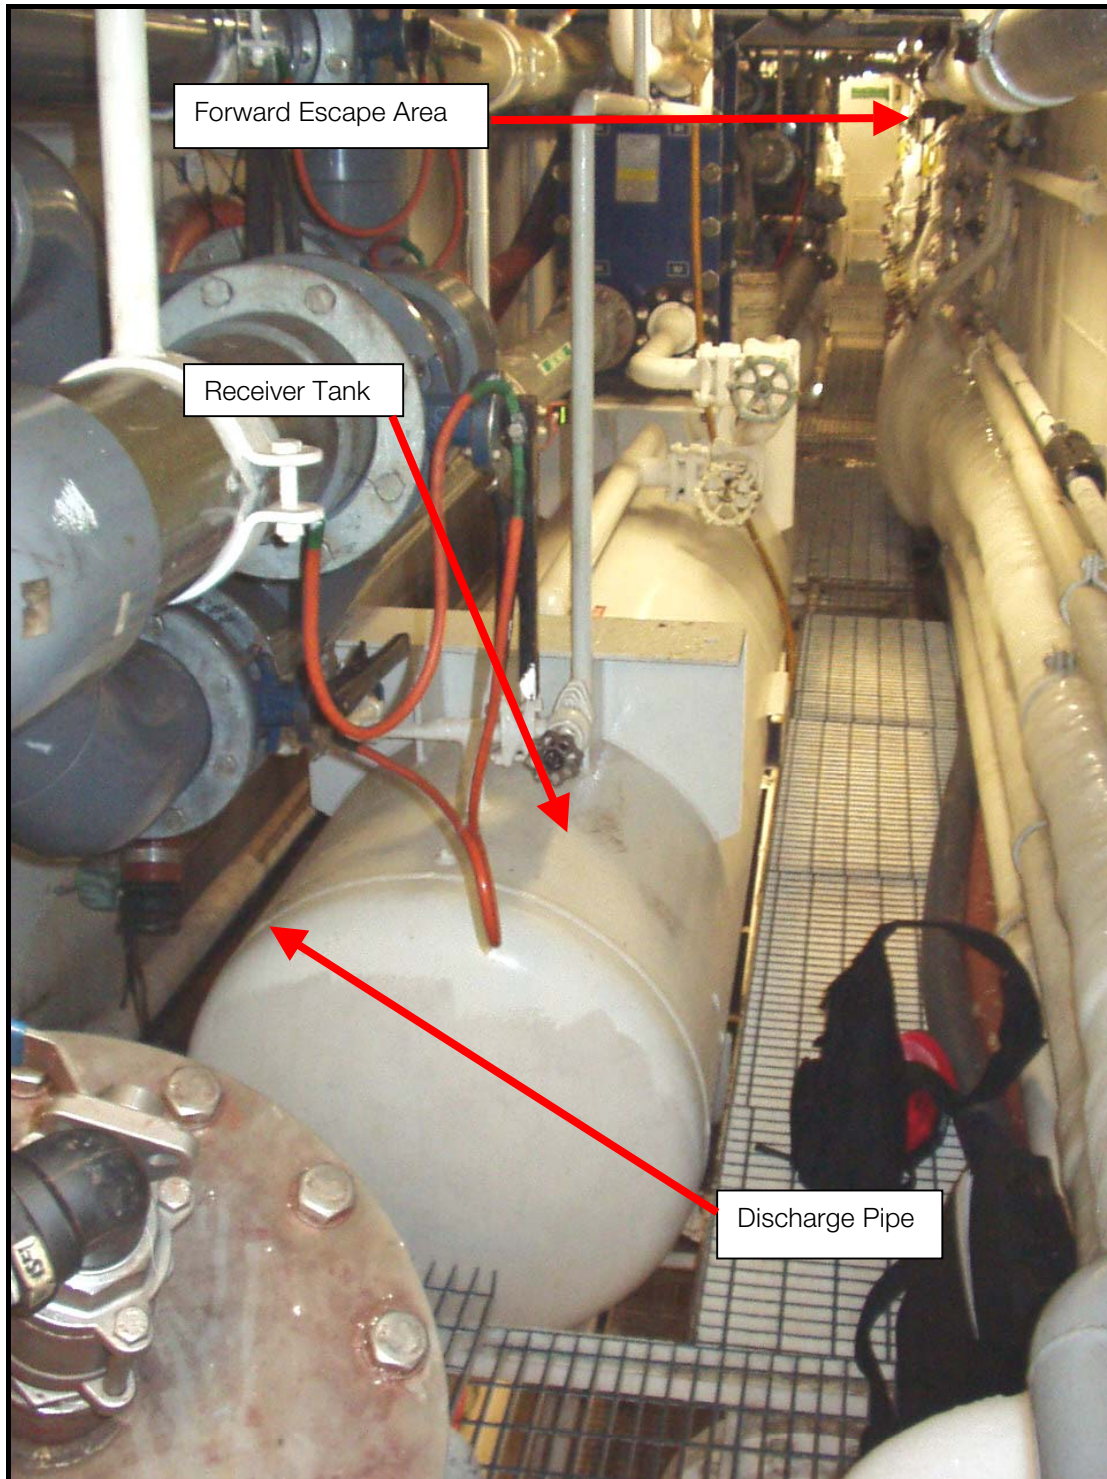
Photograph 1

The sudden failure of the discharge pipe allowing a large quantity of ammonia to vent may have been caused by the rapid drop in temperature in the area of the initial leak. When the leak first occurred the effect of expanding gas might have chilled the adjacent material thus altering its physical properties causing the failure to occur over a larger area.

- Given the serious danger ammonia poses, specific drills for ammonia leaks should be mandatory on fishing vessels carrying ammonia.
- The section of pipe that failed was heavily rusted.

- The pipe that failed was not readily visible due to it being behind large condenser pipes. It is likely that the line was not visually inspected on a regular basis because of its situation.

1. A compressor be carried on board to ensure BA bottles can be refilled.
2. The company put in place a scheduled inspection system to ensure all ammonia pipes are inspected every 6 months and replaced if required. *At the time this report was being compiled sections of piping had been marked for replacement.*

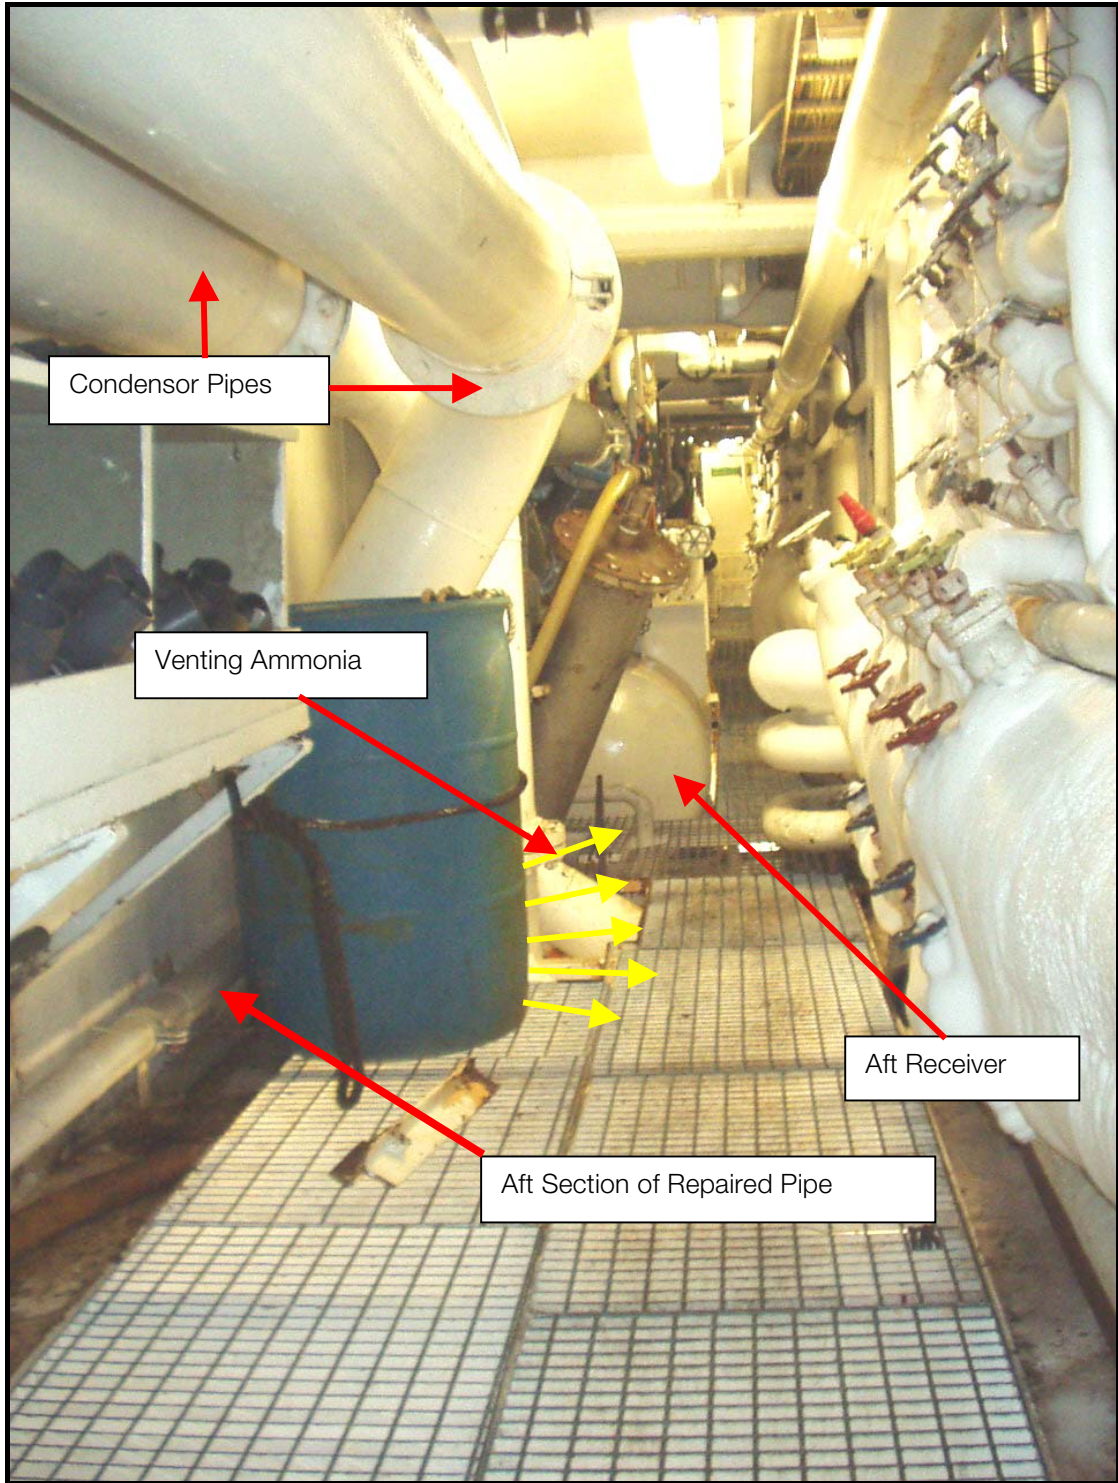
Photograph 2

The pipe that failed was the discharge line from the receiver. It was under continual pressure of 12 atmospheres (12 bar). It can only be closed down when the entire system is shut down (See *Photographs 2 & 3 - Replaced section of pipe viewed from aft and forward*).

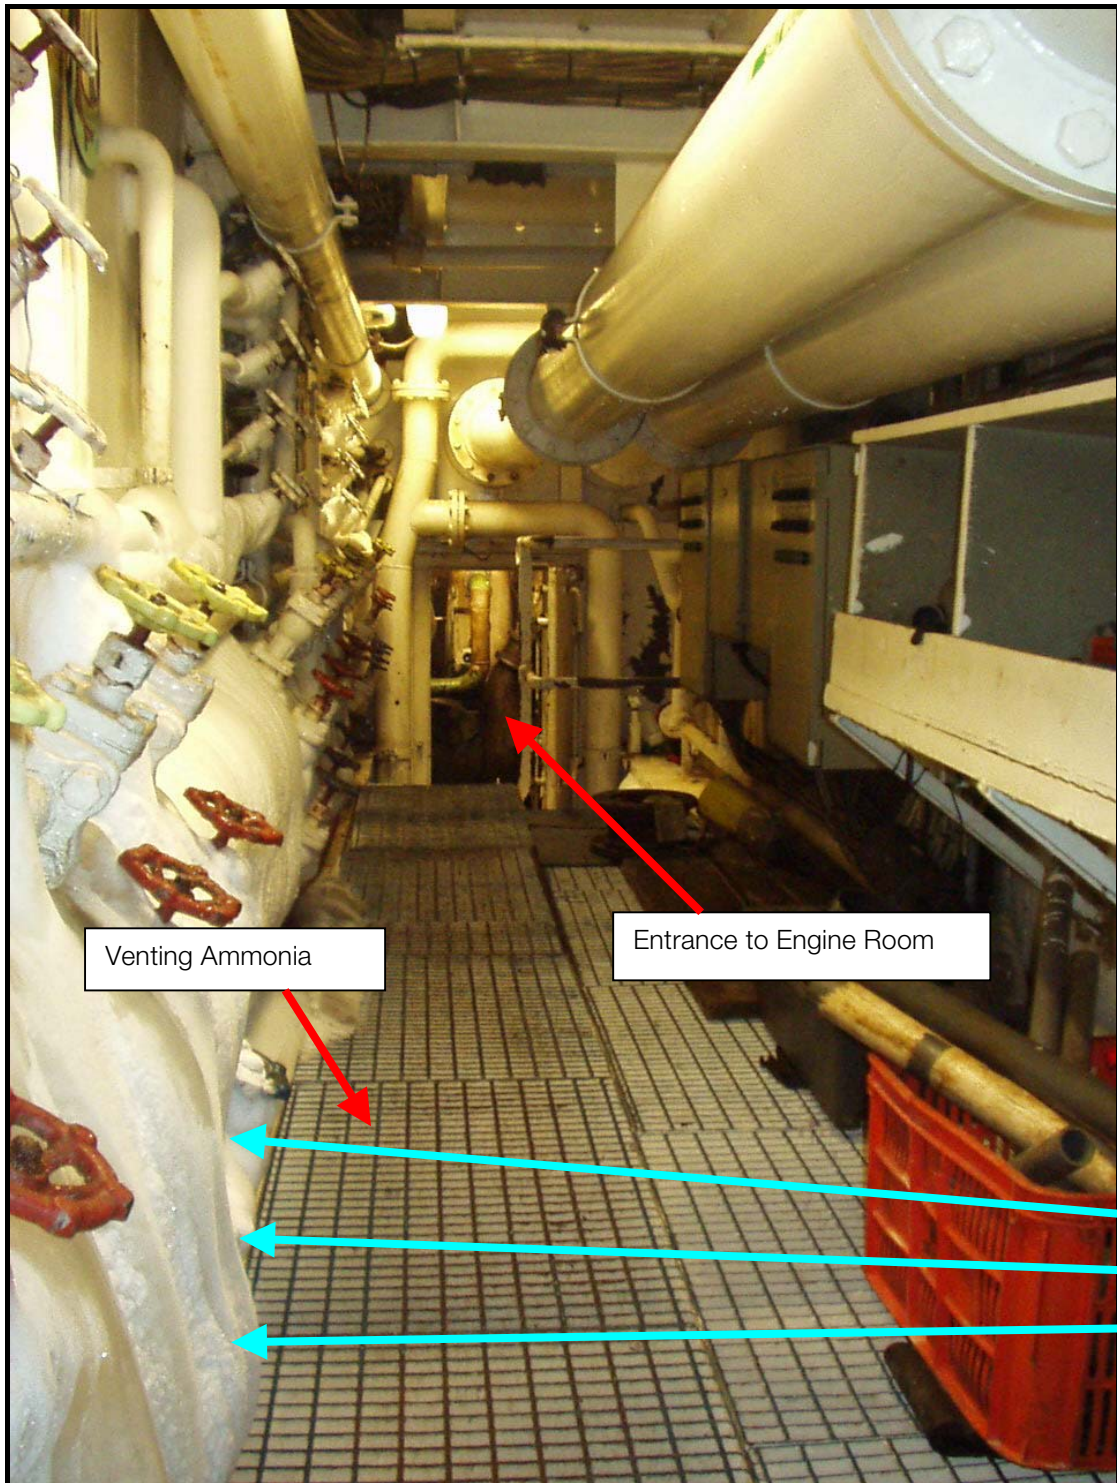
Photograph 4

The three crew exited the pipe alley by running aft to the engine room (See *Photograph 4*).

The pipe alley is ventilated from positive pressure exerted by the engine room blowers. This forces air into the alley from the engine room (See *Photograph 4 - Engine room entrance viewed from position of leak*).

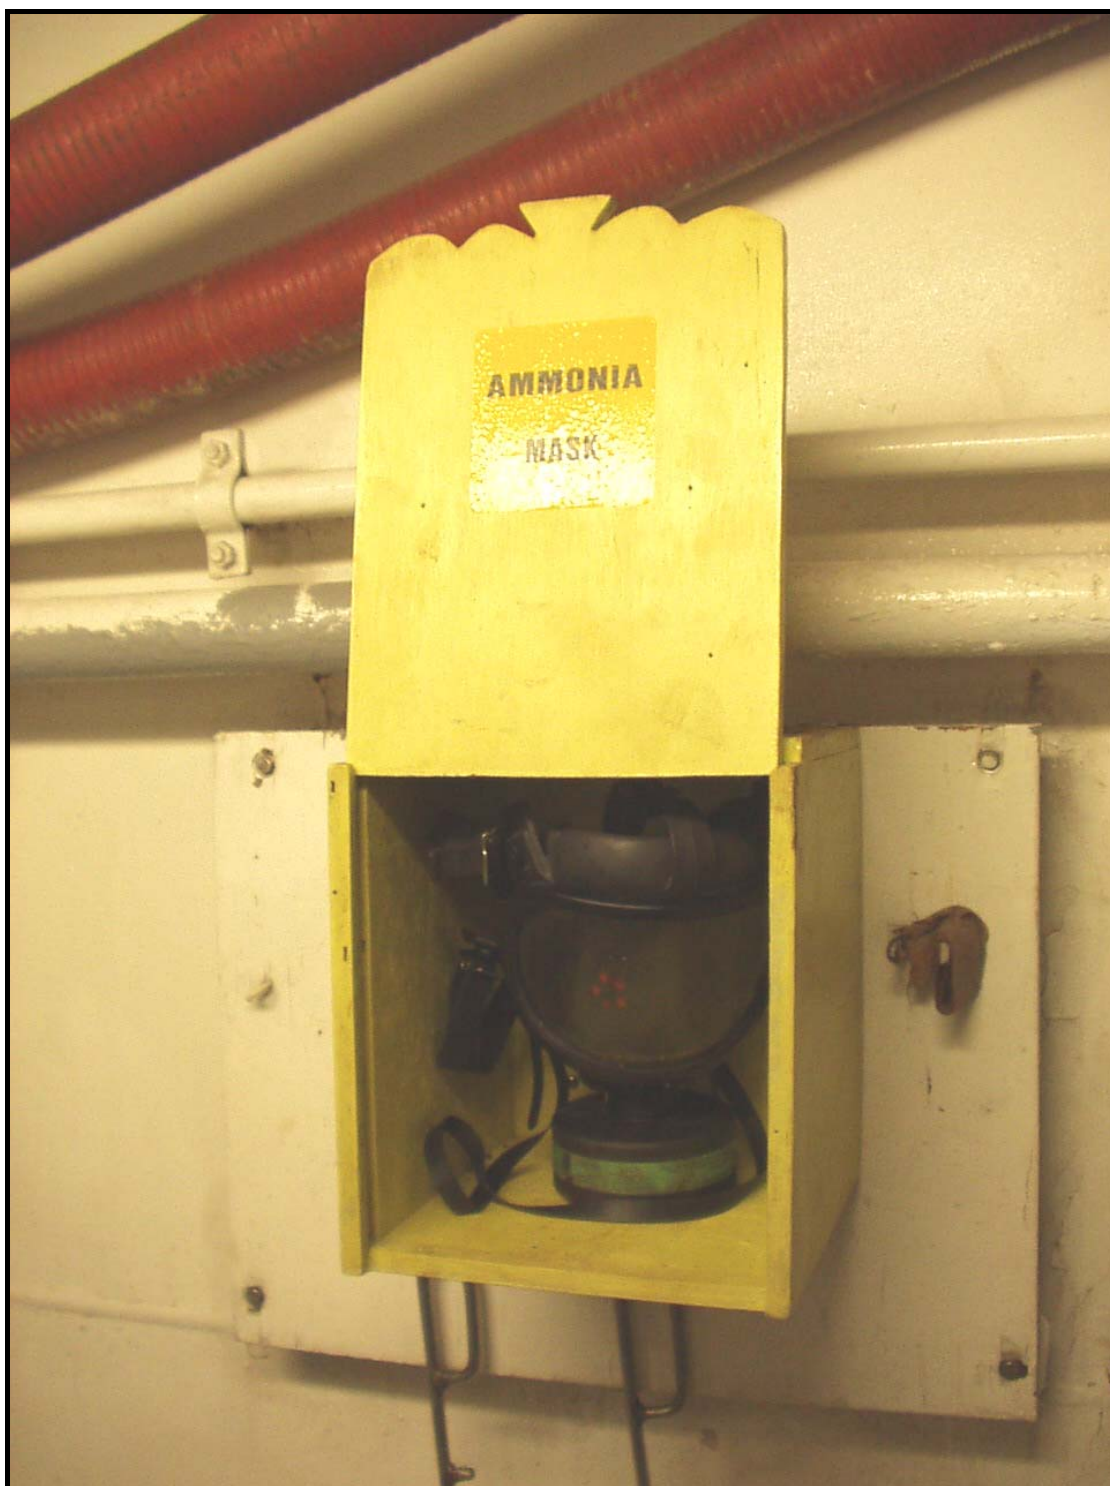
Photograph 5

The pipe alley has two ammonia masks and general quarters alarms in the catwalk section on the starboard bulkhead of the alley (See *Photograph 5 - Photograph of mask & Figure 1 showing location*).

8. The company considers installing fixed ammonia detection units.
9. The company purchase additional ammonia masks and ensure that within confined spaces, where ammonia is likely to vent, there are masks present for the maximum number of crew likely to be in the space in question.

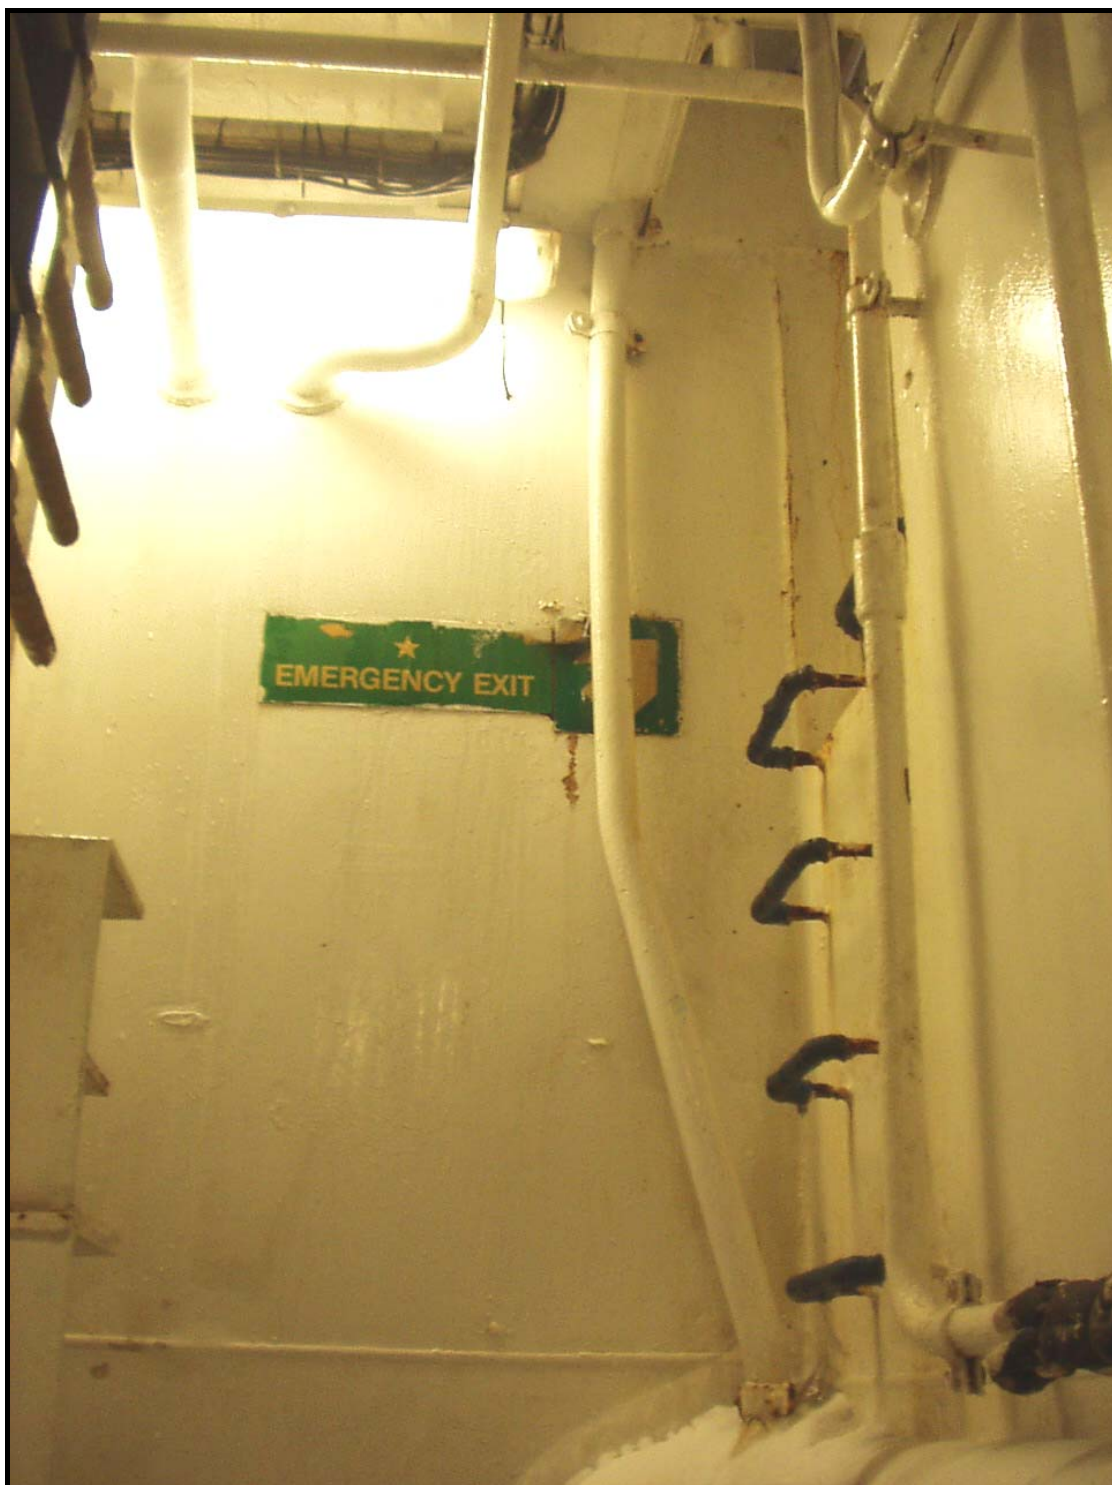
Photograph 6

Due to the positive pressure from the aft section of the alley, the ammonia expanded forward from the venting point. For this reason the crew escaped via the engine room. They knew that after passing through the venting ammonia they could breathe safely. The other option was to run forward, hopefully in advance of the expanding ammonia, and escape up the ladder at the forward end of the pipe alley (See *Photograph 6 - Emergency exit and escape rungs*).
