A Case Study of Pipework Fracture due to Hydraulic Shock in an Ammonia System

Bent Wiencke
Corporate Engineering for Nestlé USA, Inc. and Nestlé Canada
Glendale, California

Abstract

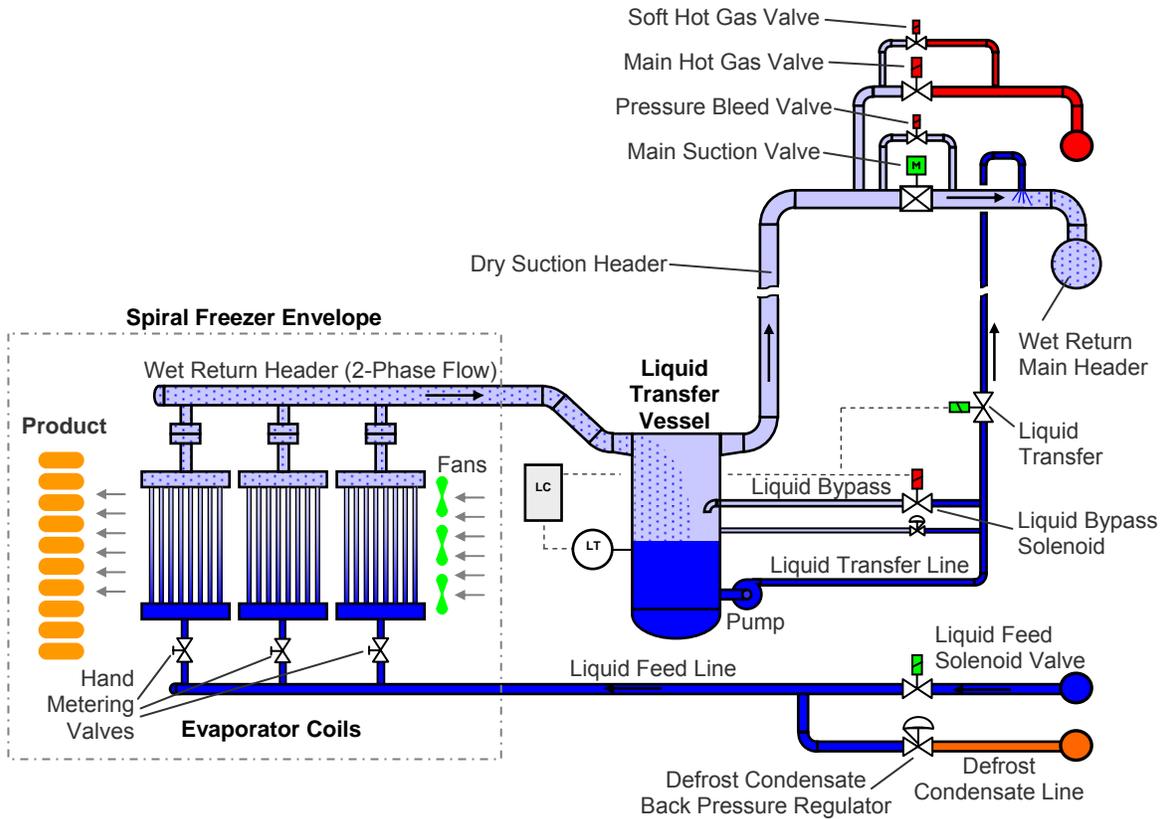
Figure 1: Schematic of evaporator, valve group and liquid transfer vessel arrangement of Line 4 Spiral freezer.

The Line 4 spiral freezer was installed and placed in service in 1993. The freezer is located on the lower level of the two story factory. Since the elevation difference of the suction riser between the outlet of the evaporator and the main suction header is more than 40 ft, performance penalties were noted shortly after the freezer was placed in operation. To improve the performance of the freezer, a liquid transfer vessel was installed at the evaporator outlet of the freezer with the suction line sloping from the evaporator outlet to the liquid transfer vessel. The purpose of the liquid transfer vessel was to separate liquid from the vapor and pump it, via a mechanical pump, to the main suction header located on the roof. A schematic of this arrangement is shown in Figure 1. Upon detecting an operating level above the set point, a liquid level controller (LC) energizes the liquid transfer solenoid valve located between the pump and the main suction header to permit pumping the liquid to the main suction header located on the roof. When the operating level of the vessel is below the set point, a liquid bypass solenoid valve located between the pump opens to bypass liquid back to the liquid transfer vessel.

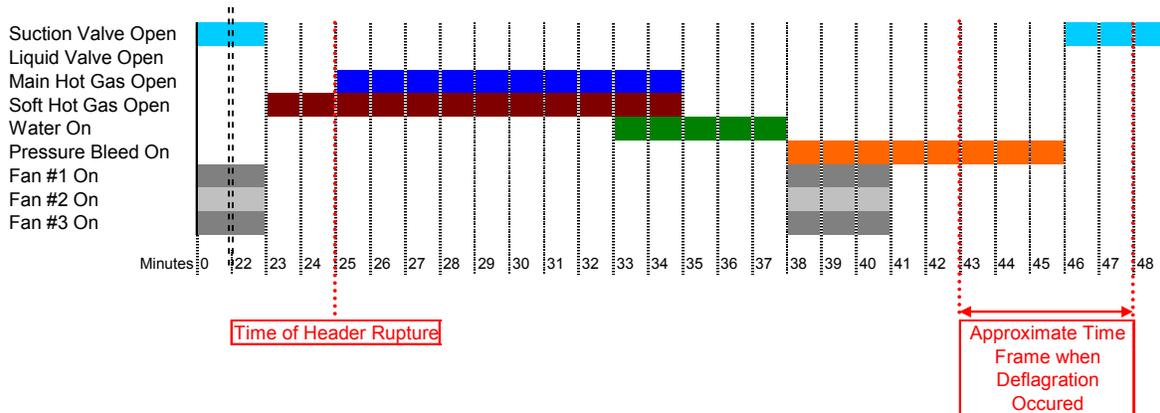
Figure 2: Defrost sequence of Line 4 spiral freezer.

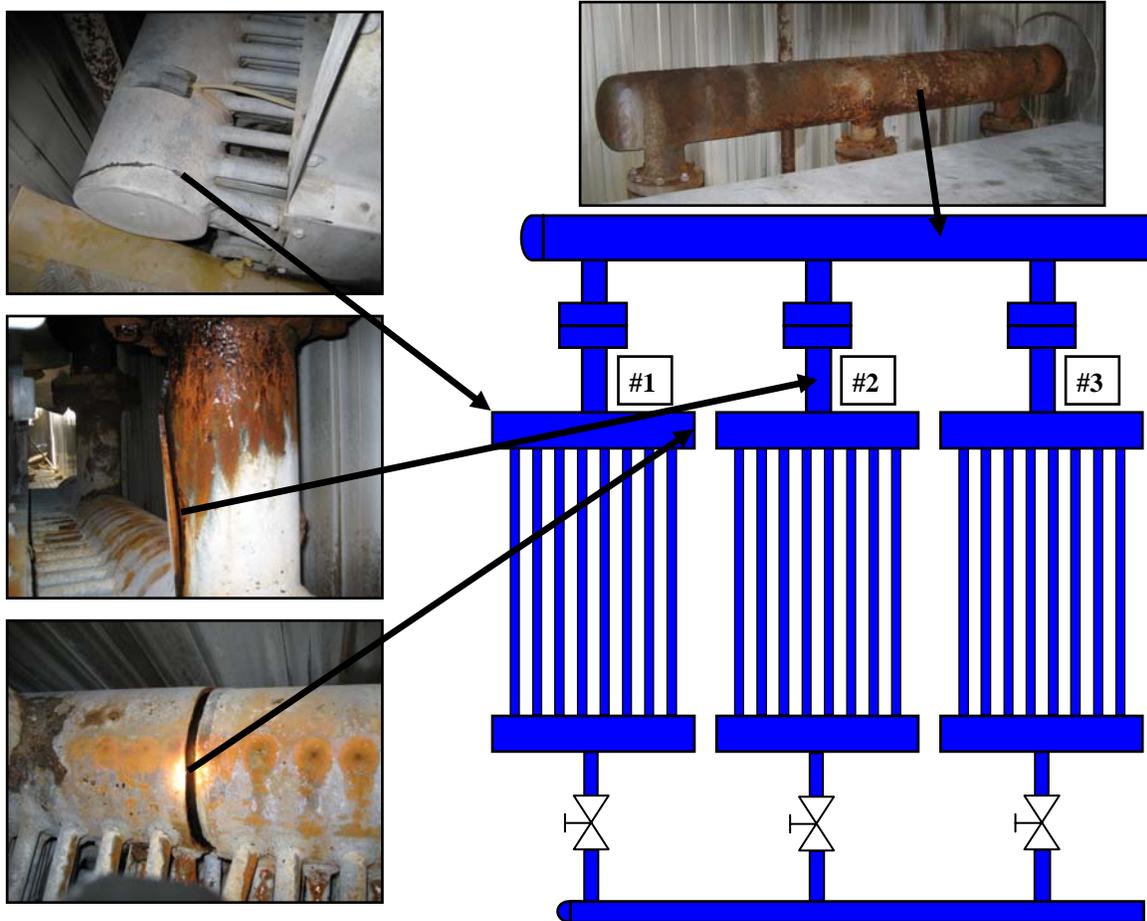
A visual inspection of the Line 4 spiral freezer evaporator coils confirmed that two out of the three suction manifolds had ruptured. A schematic of the evaporator coil indicating the location of the ruptures and photos of the actual ruptures are provided in Figure 3. A visual examination of the left suction header (#1 in Figure 3) confirmed that it had experienced circumferential cracking in close proximity to the left end plate. This cracking extended approximately 240° around the circumference of the header. The cracking stopped progressing when it intersected the header-to-tube welds. This detail is provided in Figure 4. The right end plate was completely detached from the body of the header and wedged between the left and middle suction headers as shown in Figure 3. Figure 5 provides a close-up photograph.

A visual examination of the center suction header (#2 in Figure 3) confirmed that the branch connection joining the branch to the suction header had experienced cracking. This cracking, which extended over the full length of the branch connection, is shown in the close-up photographs provided in Figure 6. This cracking was oriented roughly parallel with the longitudinal axis of the branch connection. As it approached the upper flange connection it bifurcated, resulting in the detachment of a triangular segment.

A visual examination of the right suction header (#3 in Figure 3) and the 10” main suction header did not reveal any noticeable defects. There was no evidence of cracking or significant dimensional changes.

Figure 3: Location of coil ruptures and photographs of actual manifolds showing cracking.

The results of the preliminary visual examination indicated that the cracking in both of the failed headers was the result of a sudden overload pressure condition. There was no evidence of significant weld defects, pre-existing cracking or other significant service-related deterioration that could have caused or contributed to the failure of these headers.

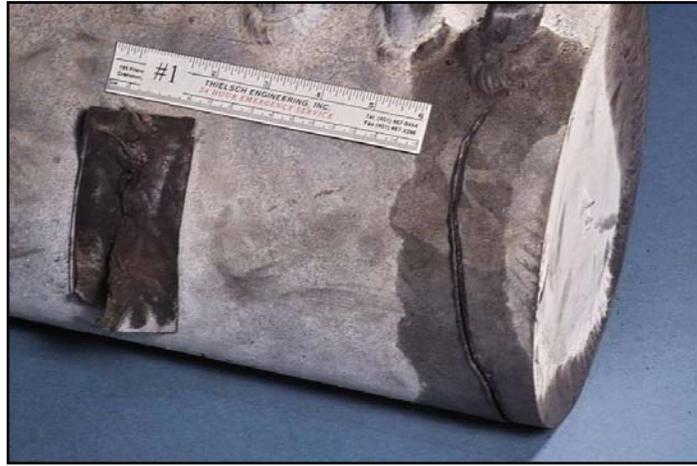
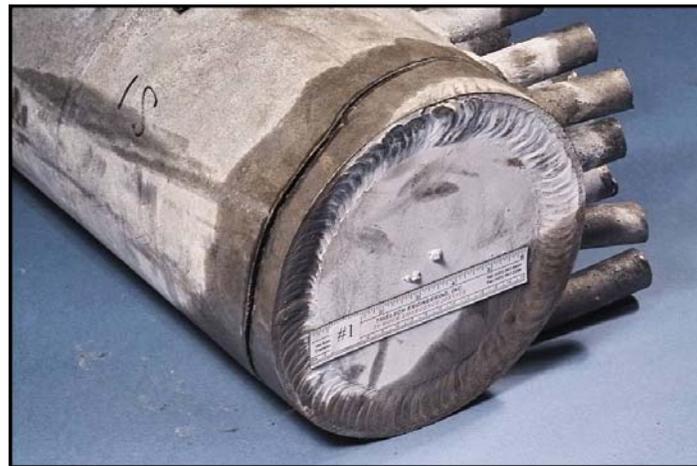
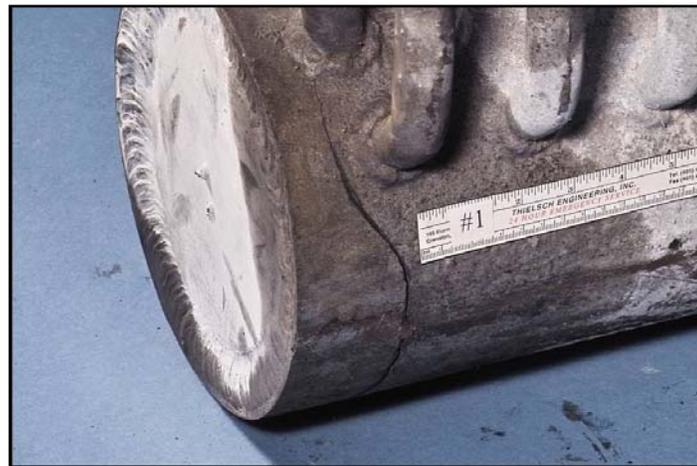
Figure 4: Close-up photographs of cracking adjacent to left end plate of suction header #1.

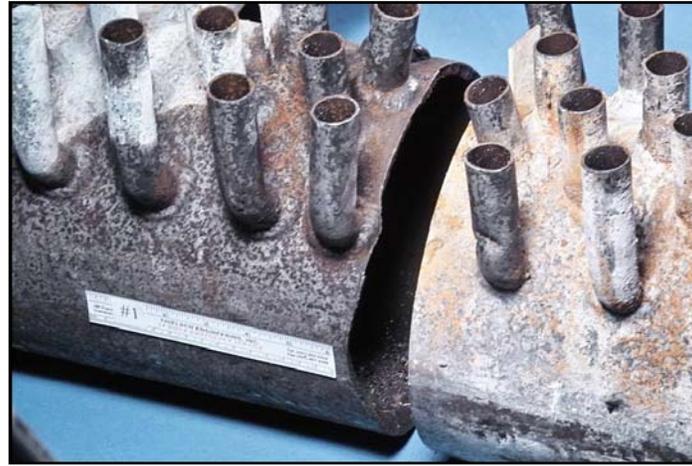
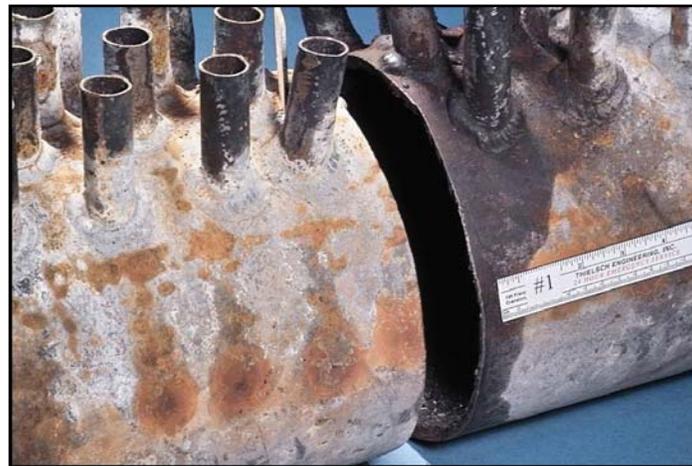
Figure 5: Close-up photographs of cracking adjacent to right end plate of suction header #1.

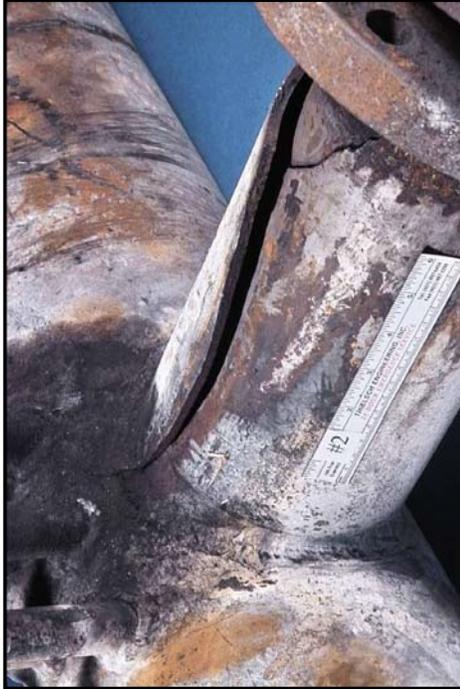
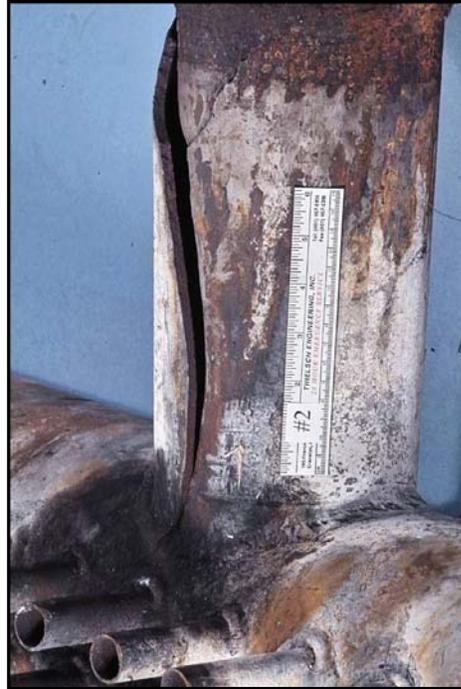
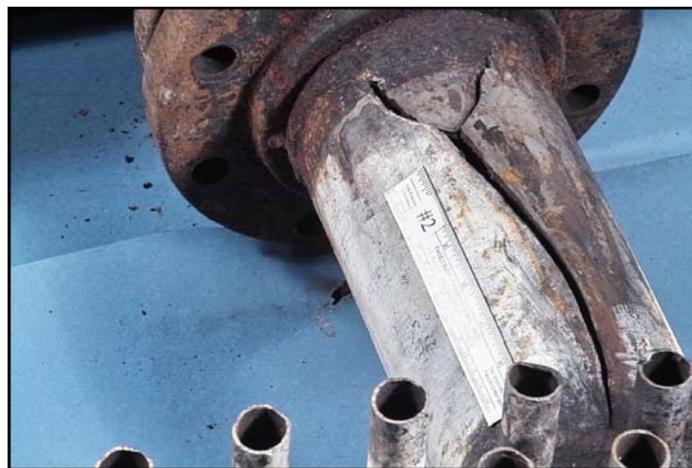
Figure 6: Close-up photographs of cracking in branch connection of suction header #2.

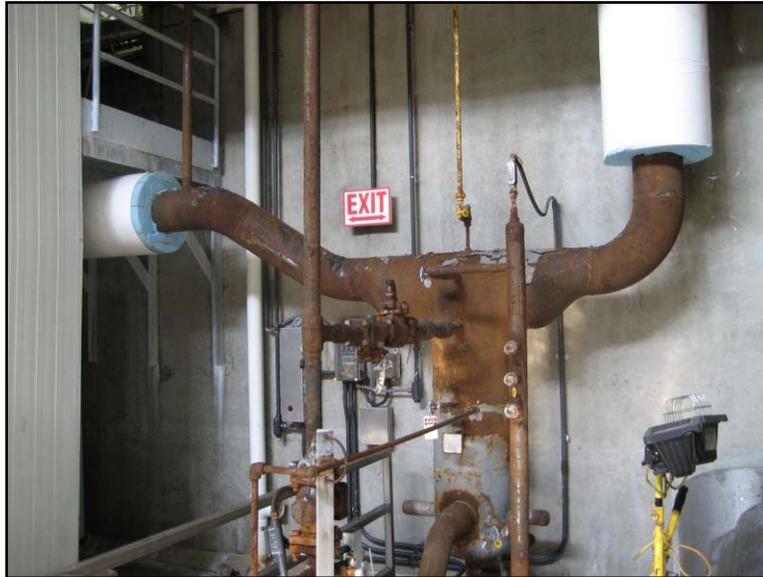
Focusing on the liquid transfer vessel design, it became apparent that this vessel could create a liquid trap during abnormal operating conditions, e.g. if the vessel was overfilled. This potential liquid trap is shown in Figure 7. With a large enough driving force, such as a large hot gas valve opening, this trapped liquid could form a vapor propelled liquid slug, which upon impact with an end cap, could generate a hydraulic shock.

Figure 7: Post Incident photograph of liquid transfer vessel with insulation removed.

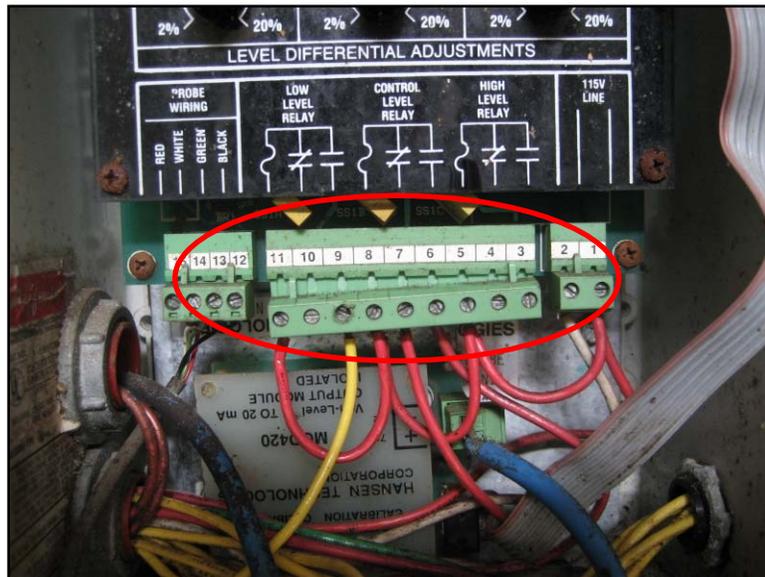
- The terminal strip as shown in Figure 8 was not pushed all the way in. In the position shown, neither the liquid transfer solenoid valve nor the bypass solenoid valves could be activated. When pushing the terminal strip upwards by approximately 1/64" the liquid transfer solenoid valve would open when simulating a high level. To activate the bypass solenoid valve the terminal strip needed to be pushed further upward. After the terminal strip was pushed all the way onto the socket, a screw driver was required to break the strip loose from the socket again. The possibility that the terminal strip became loose from the deflagration was ruled out.
- The high level relay was not used or interlocked with any other devices.

Figure 8: Loose terminal strip on liquid level controller.

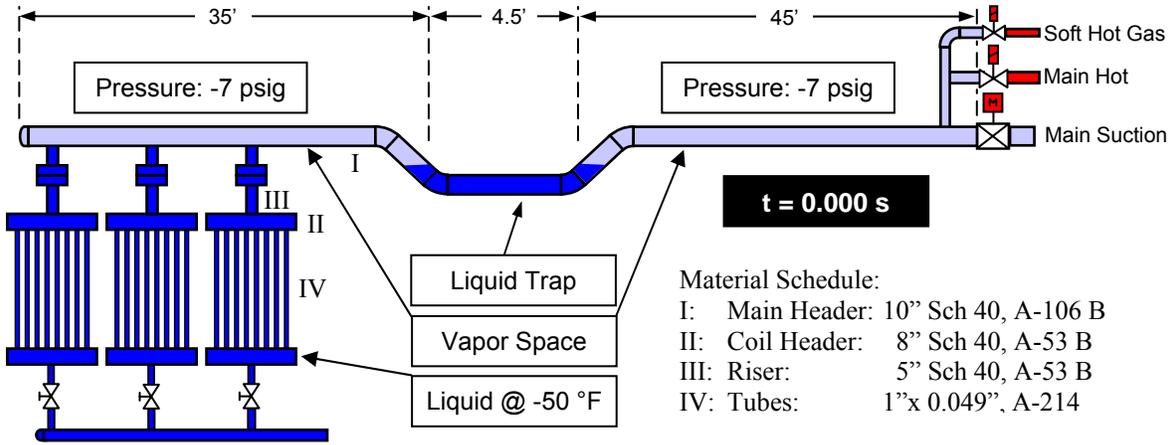
Figure 9 is a simplified illustration of the actual piping arrangement. In order to physically describe and understand the mechanisms that lead to the pipe rupture, a few assumptions and calculations are required. As a first step it must be assumed that the pressure excursion caused by the hydraulic shock exceeded the bursting pressure of the components affected by the shock.

Figure 9: Simplified schematic of actual piping arrangement. Trapped liquid is at rest.

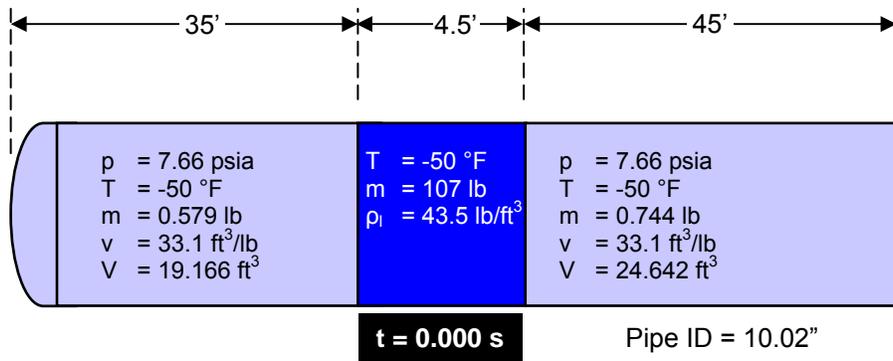
Figure 10: Liquid slug at its initial resting position with a vapor pressure of 7.66 psia (-7 psig).

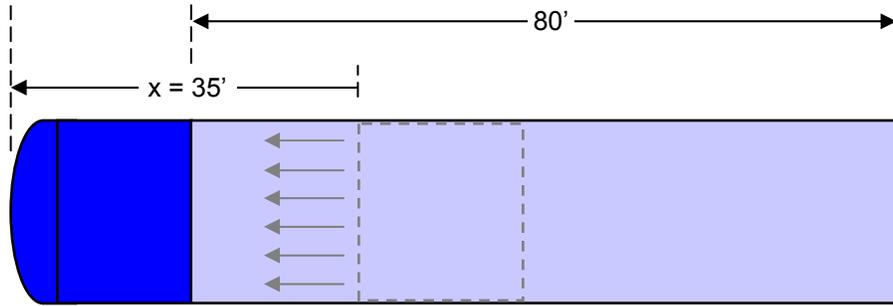
Figure 11: Liquid slug at its final resting position after traveling 35 ft.

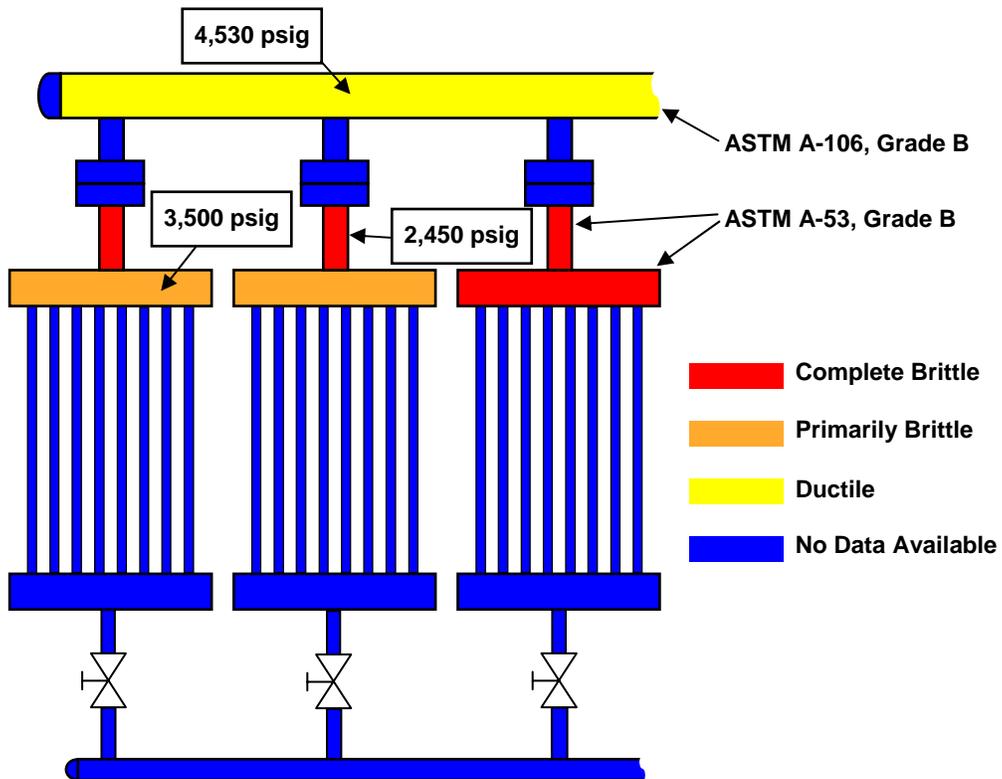
In an effort to determine the approximate pressure at which the manifolds ruptured, a Finite Element Analysis (FEA) using ANSYS software and Fracture Mechanics using NASCRAC software was performed. Based upon the results of these analyses and the results of the metallurgical evaluation and mechanical testing performed, the suction header of the first coil likely ruptured at a pressure of around 3,500 psig. The riser of the second coil likely ruptured at a pressure around 2,450 psig. The results from the FEA, fracture mechanics and mechanical testing are summarized in Figure 12.

Figure 12: Material behavior of manifolds and actual bursting pressures.

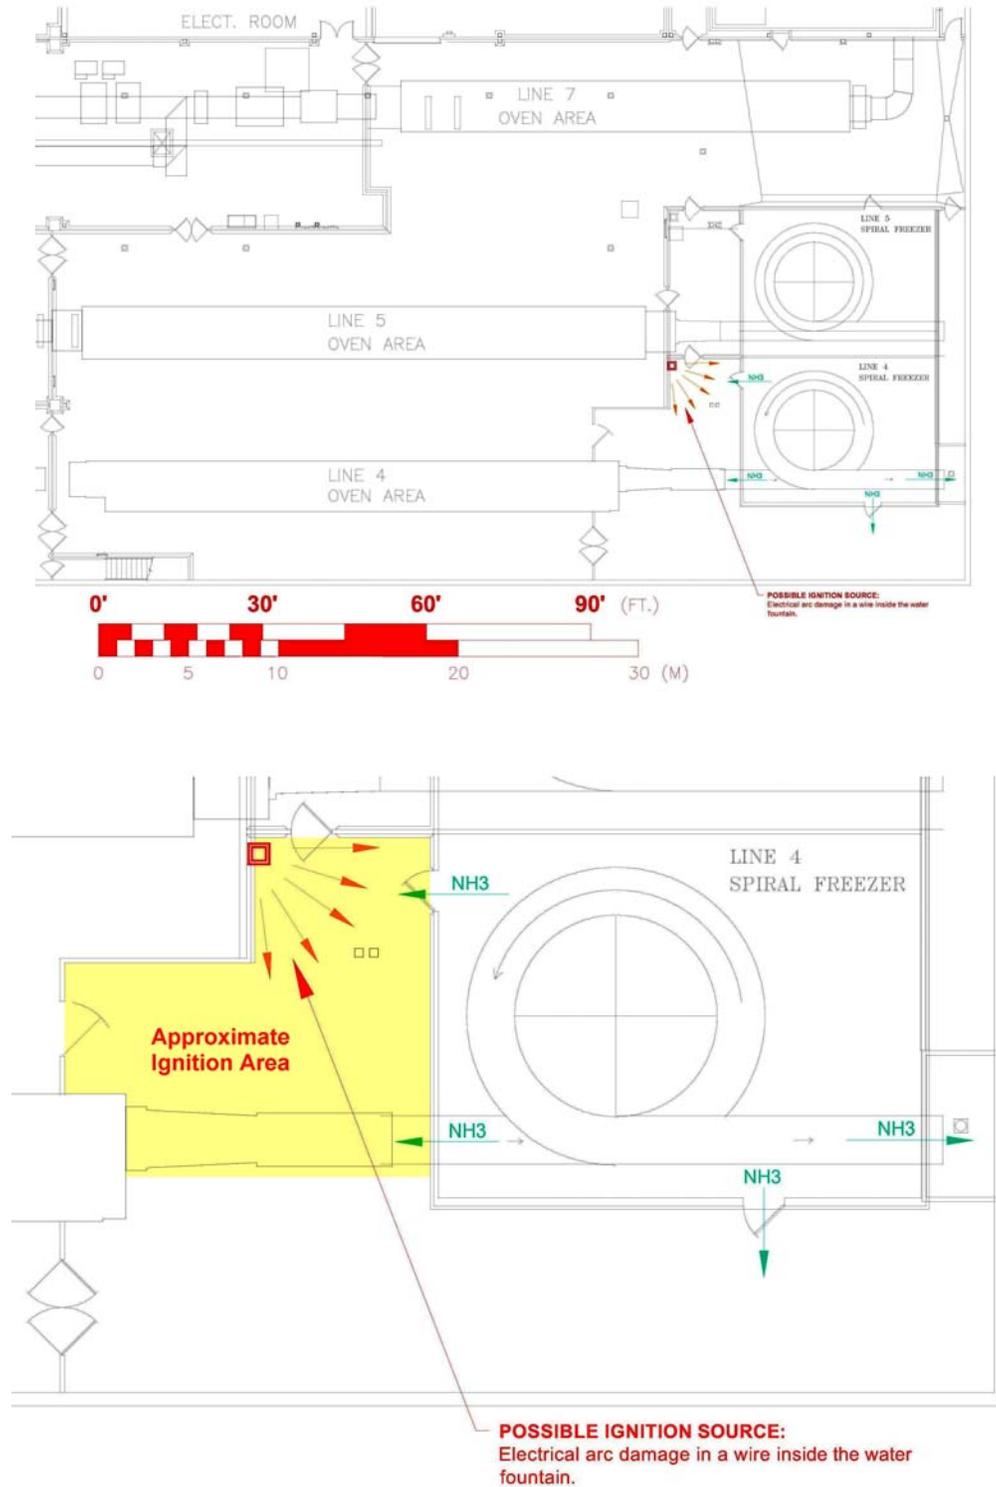
As will be shown in a later section, it was estimated that approximately 5,300 lb_m of ammonia in liquid and vapor form escaped the Line 4 spiral freezer just before the deflagration. The author assumes that most of the liquid escaped the Line 4 spiral freezer through the scuppers. It then entered the floor drains. Since the freezer man-doors were left open to aid the defrost most of the ammonia vapor escaped into the lower level space where the spiral freezer was located. When the spiral freezer fans were turned on by the defrost control sequence ammonia vapor was also pushed out of the out-feed conveyor opening into other areas of the factory. The highest ammonia concentration would have accumulated outside the freezer man-doors. A post incident examination of the area adjacent to the spiral freezer revealed numerous tell-tale signs of an ammonia deflagration. Burn marks were found on plastic PVC piping, a paper towel dispenser and other objects. The characteristics and pattern of the burn marks pointed towards a drinking fountain that was installed approximately 2 weeks prior to the deflagration. Upon further examination it was determined that the arcing found in a wire inside the drinking fountain was the likely ignition source. The room layout and the location of the drinking fountain are shown in Figure 13. A photograph of the drinking fountain is provided in Figure 14. Also shown in the photograph is the paper towel dispenser and PVC piping showing burn marks. The flame propagation was limited to the room where the drinking fountain was located. It propagated around 10 ft east towards the Line 4 spiral freezer wall and around 25 ft south just beyond the conveyor belt feeding the spiral freezer. The approximate ignition area is also shown in Figure 13.

Figure 13: Schematic of Line 4 spiral freezer layout and location of drinking fountain.

- Thirteen minutes after the manifold rupture, the evaporator fans were turned on for 3 minutes. This pushed more ammonia out of the freezer and into the factory. This allowed the ammonia concentration to build up to a flammable mixture outside the freezer. See Figure 26.
- After 18 to 22 minutes, the deflagration occurs. The arcing found in a wire inside a drinking fountain was the likely ignition source. The location of the drinking fountain in relation to the Line 4 spiral freezer and the freezer man-doors is shown in Figure 13.

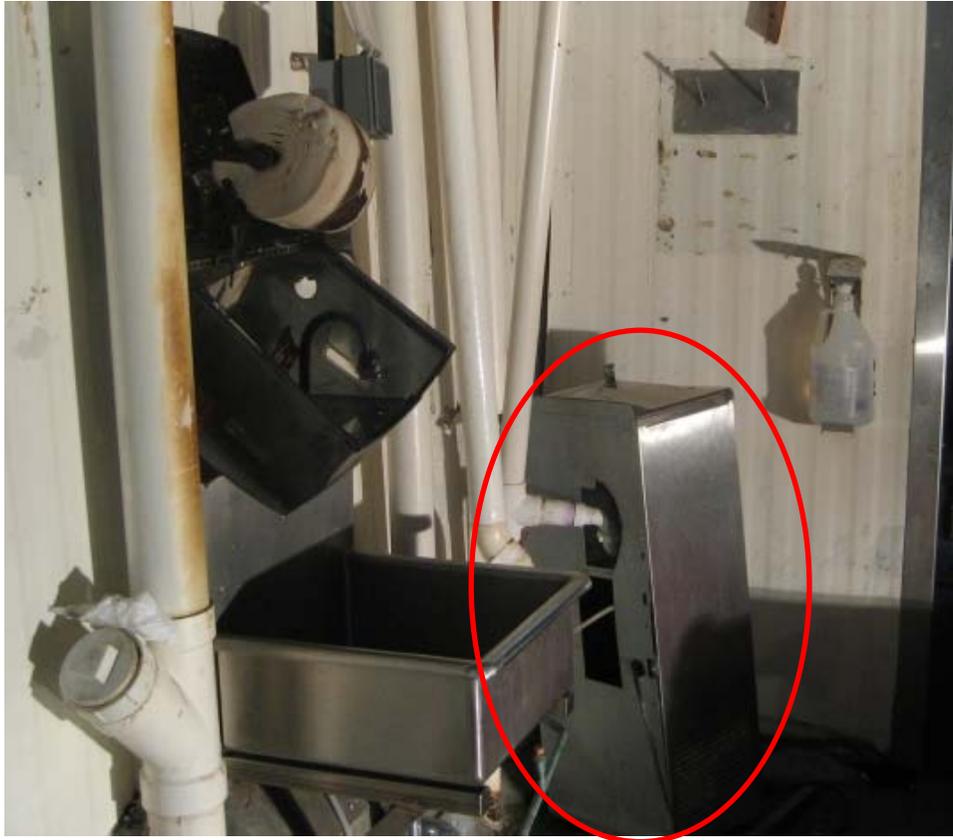
Figure 14: Photograph of drinking fountain. Also shown, burn marks on paper towel dispenser and PVC piping.

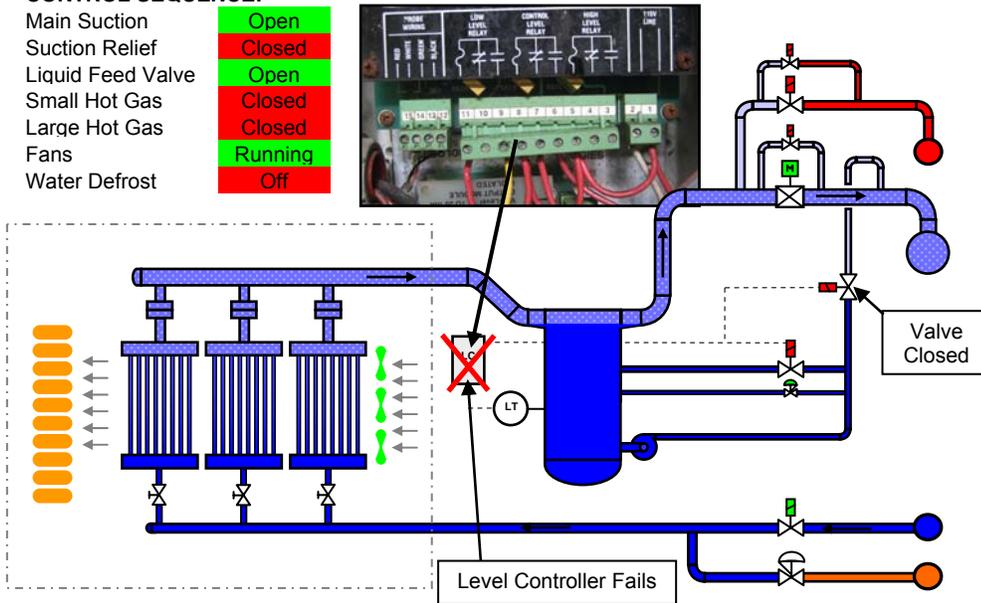
Figure 15: Schematic showing initial condition of spiral freezer just before initiating hot gas defrost. Freezer coils, liquid transfer vessel and associated piping are filled with liquid in excess.

Main Suction	Open
Suction Relief	Closed
Liquid Feed Valve	Open
Small Hot Gas	Closed
Large Hot Gas	Closed
Fans	Running
Water Defrost	Off

- Due to a failed liquid level controller and delayed initiation of the defrost cycle, the Line 4 spiral freezer, liquid transfer vessel and associated piping were filled with liquid in excess. See Figure 15.
- During the pump-out mode only a very small amount of ammonia evaporated. The pump-out mode is shown in Figure 16.
- At the end of the pump-out cycle, liquid settled in the system. The evaporator coil filled to the top and the trap formed by the liquid transfer vessel filled with liquid. The main suction line contained mainly vapor. See Figure 17.
- The soft hot gas valve opened, but was unable to build any significant amount of pressure. Most of the hot gas immediately condensed within in the system. See Figure 18.

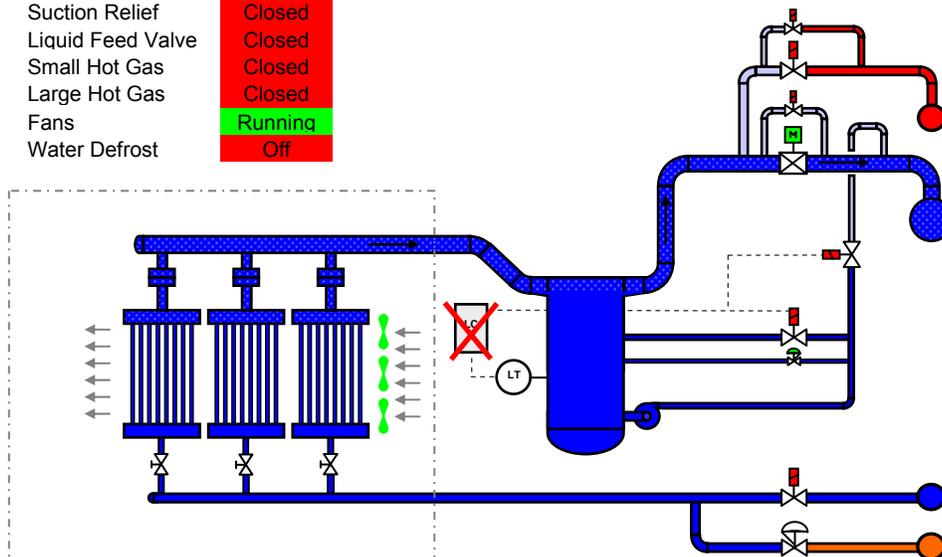
Figure 16: Schematic showing spiral freezer in pump out mode. Only a very small amount of ammonia evaporates in the evaporator coils.

Main Suction	Open
Suction Relief	Closed
Liquid Feed Valve	Closed
Small Hot Gas	Closed
Large Hot Gas	Closed
Fans	Running
Water Defrost	Off

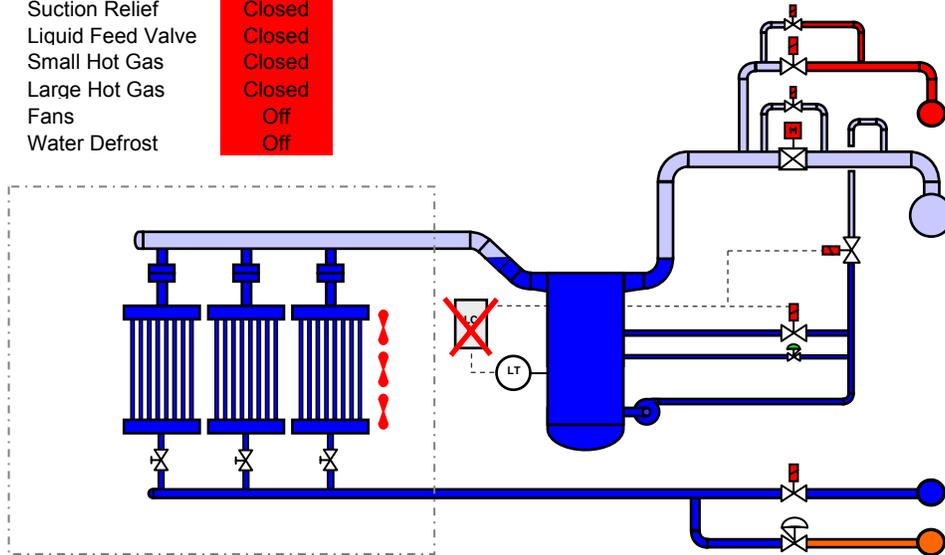
Figure 17: Schematic showing spiral freezer at the end of pump out cycle. Liquid settles in evaporator coils and liquid transfer vessel with liquid being trapped.

Main Suction	Closed
Suction Relief	Closed
Liquid Feed Valve	Closed
Small Hot Gas	Closed
Large Hot Gas	Closed
Fans	Off
Water Defrost	Off

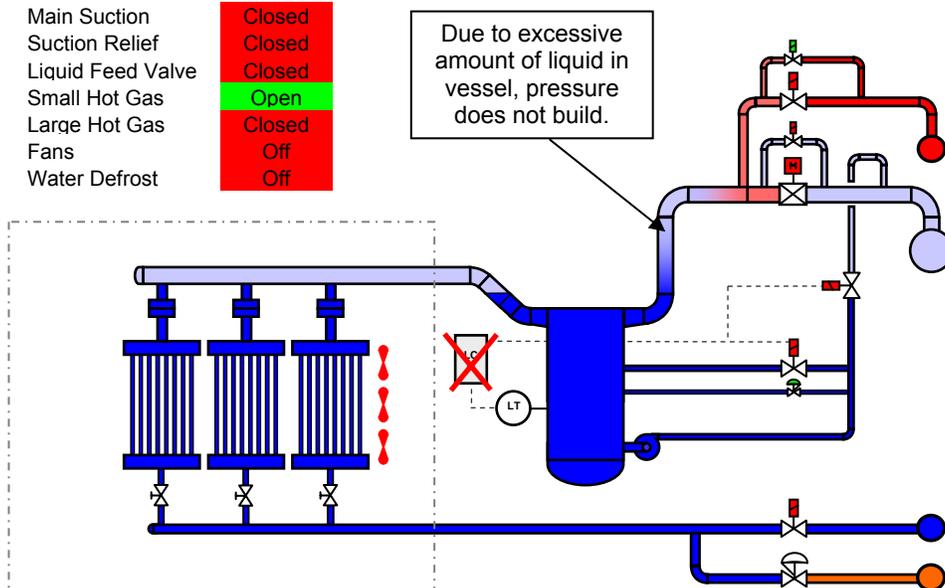
Figure 18: Schematic showing spiral freezer during soft hot gas defrost cycle.

Due to excessive amount of liquid in vessel, pressure does not build.

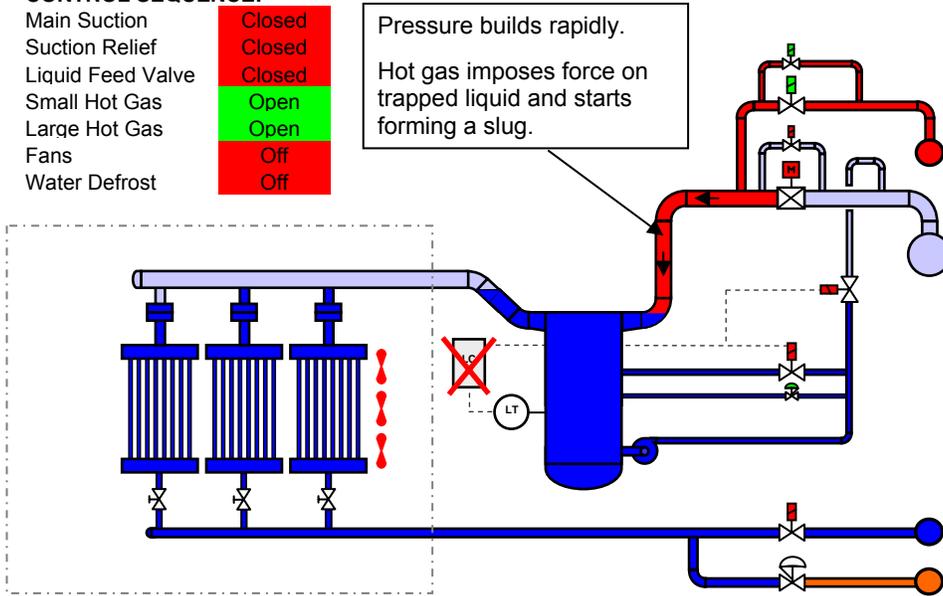
Figure 19: Schematic showing spiral freezer at the beginning of the hot gas defrost cycle with liquid slug beginning to form.

Pressure builds rapidly.

Hot gas imposes force on trapped liquid and starts forming a slug.

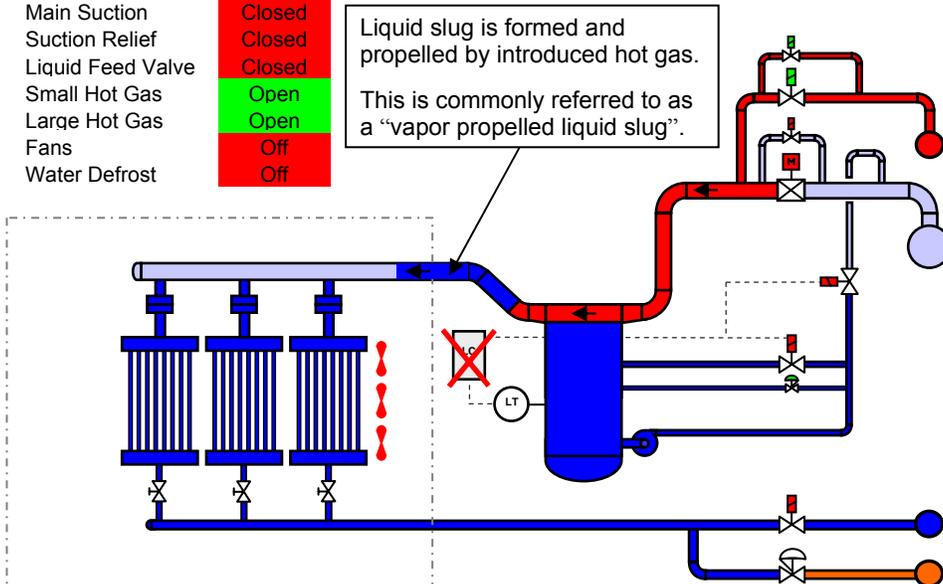
Figure 20: Schematic showing spiral freezer during the hot gas defrost cycle with “vapor propelled liquid slug” traveling down the main header towards the end cap.

Liquid slug is formed and propelled by introduced hot gas.

This is commonly referred to as a “vapor propelled liquid slug”.

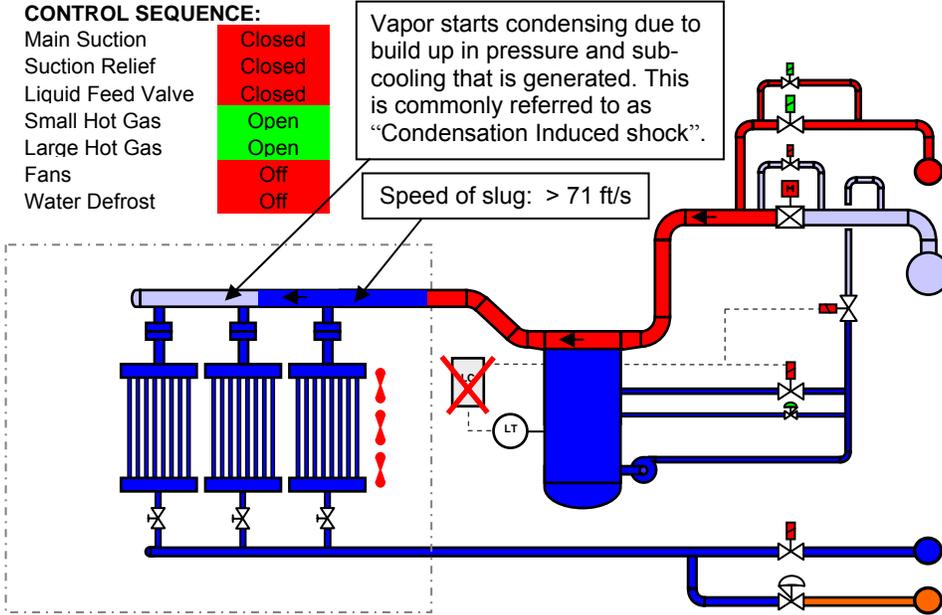
Figure 21: Vapor downstream of the liquid slug begins to collapse generating a “condensation induced shock”.

Vapor starts condensing due to build up in pressure and sub-cooling that is generated. This is commonly referred to as “Condensation Induced shock”.

Speed of slug: > 71 ft/s

- As the liquid slug traveled down the main header, vapor downstream of the slug was compressed and as the vapor reached a critical condition the vapor collapsed. This is commonly referred to as “condensation induced shock”. See Figure 21.

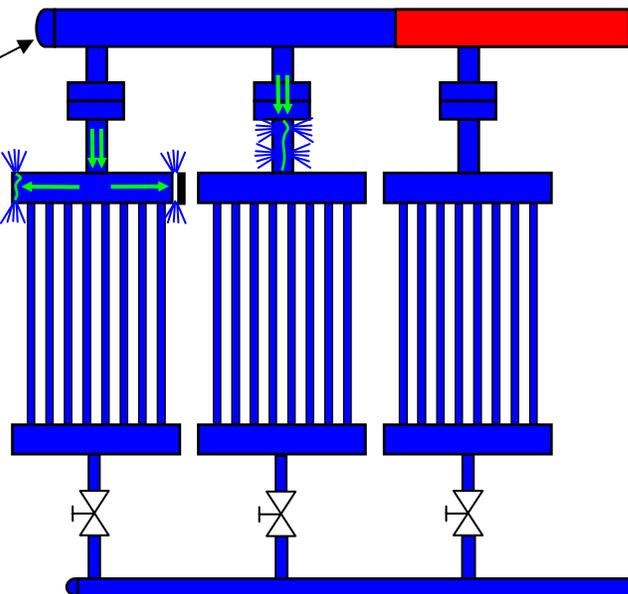
Figure 22: Impact of liquid slug with end cap and resulting hydraulic shock generates a transient pressure between 3,500 psig and 4,530 psig. Model and calculations suggests a bursting pressure of 4,053 psig.

Impact of slug with end cap generates a hydraulic shock with a resulting transient pressure between 3,500 and 4,530 psig.

Time difference between hot gas valve opening and rupture: < 0.855 sec

- The vapor propelled liquid slug passed the riser of the third coil and impacted with the end cap. Based on the results of the metallurgic testing, finite element and fracture mechanics analysis, the resulting hydraulic shock generated a transient pressure between 3,500 psig and 4,530 psig. The model and calculations presented in this paper would suggest a bursting pressure of 4,053 psig. The shock wave was transmitted through the header system and caused the suction header of the first coil to rupture in two places and the riser of the second coil to rupture in one place. See Figure 22.

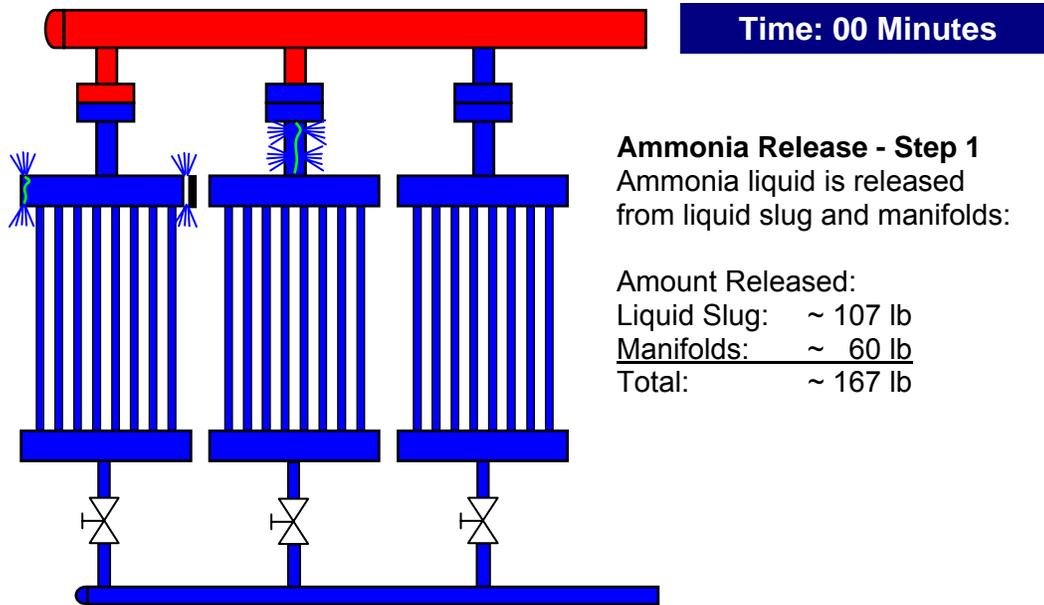
Figure 23: First and initial step of ammonia release.

- The resulting ammonia release occurred in a multi step sequence as the spiral freezer controller continued to cycle through the defrost cycle steps. During the first and initial step, the liquid contained in the liquid slug and the ruptured manifolds was released. The amount of ammonia contained in the liquid slug and ruptured manifolds was estimated to be approximately 107 lb_m and 60 lb_m respectively. See Figure 23.

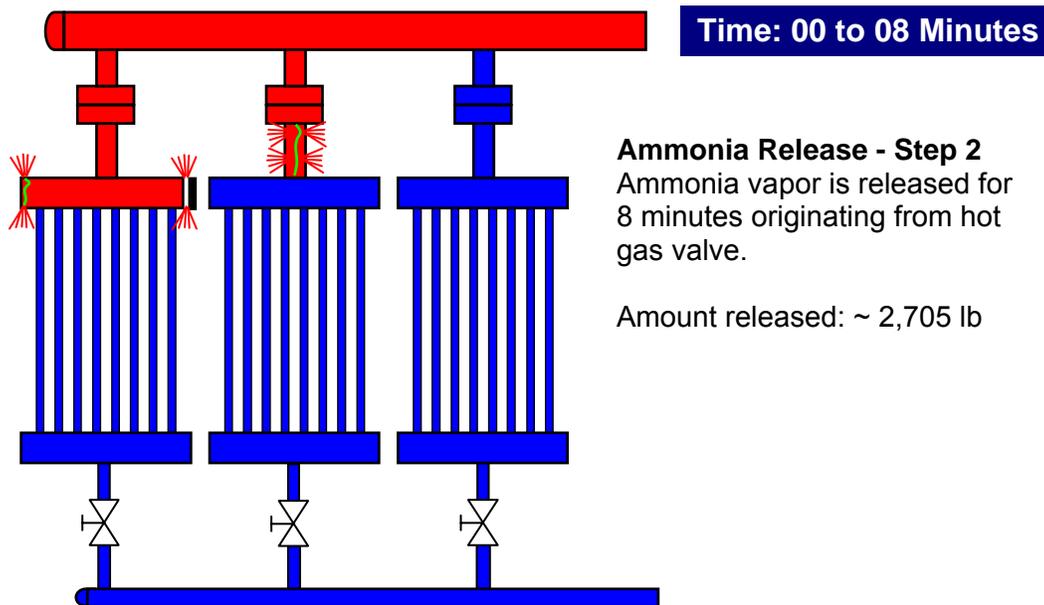
Figure 24: Step two of ammonia release.

- After the liquid from the liquid slug was released, the hot gas valves continue to supply hot gas into the system, which was consequently released through the ruptured manifolds. The amount of ammonia released during this 8 minute time frame was approximately 2,705 lb_m. See Figure 24.

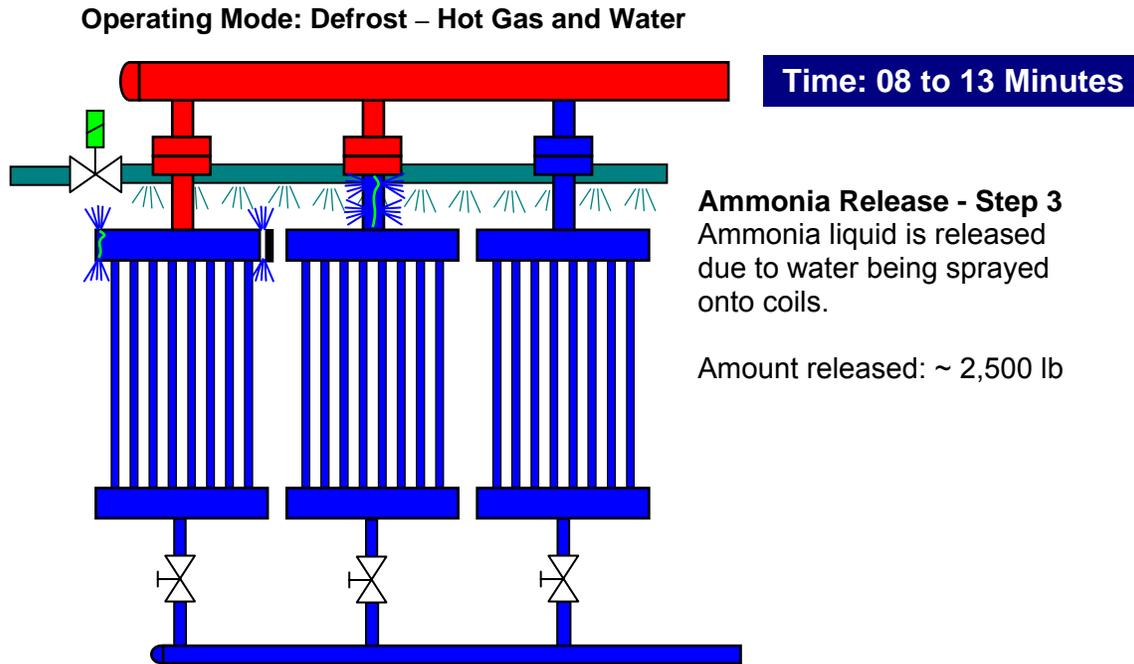
Figure 25: Step three of ammonia release.

- Eight minutes after the manifold rupture, the water defrost was actuated. This introduced a very high heat load into the evaporator coils for 5 minutes. The liquid ammonia inside the evaporator coils began to swell and evaporate violently. It is

reasonable to assume that 70% of the liquid contained in the evaporator coil escapes through the ruptured manifolds, which is equivalent to 2,500 lb_m. See Figure 25.

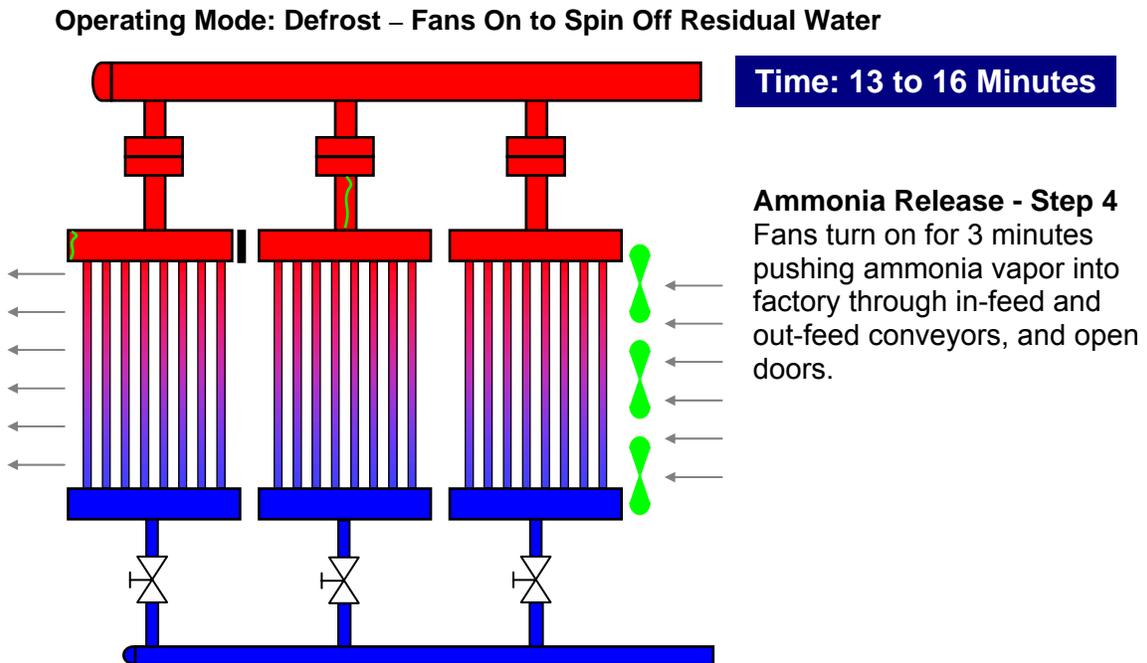
Figure 26: Step four of ammonia release.
