Ammonia Liquid Leak Incident Case Study

Date Incident Occurred: January 15, 2011 at approximately 7:15 PM

Summary of the Incident

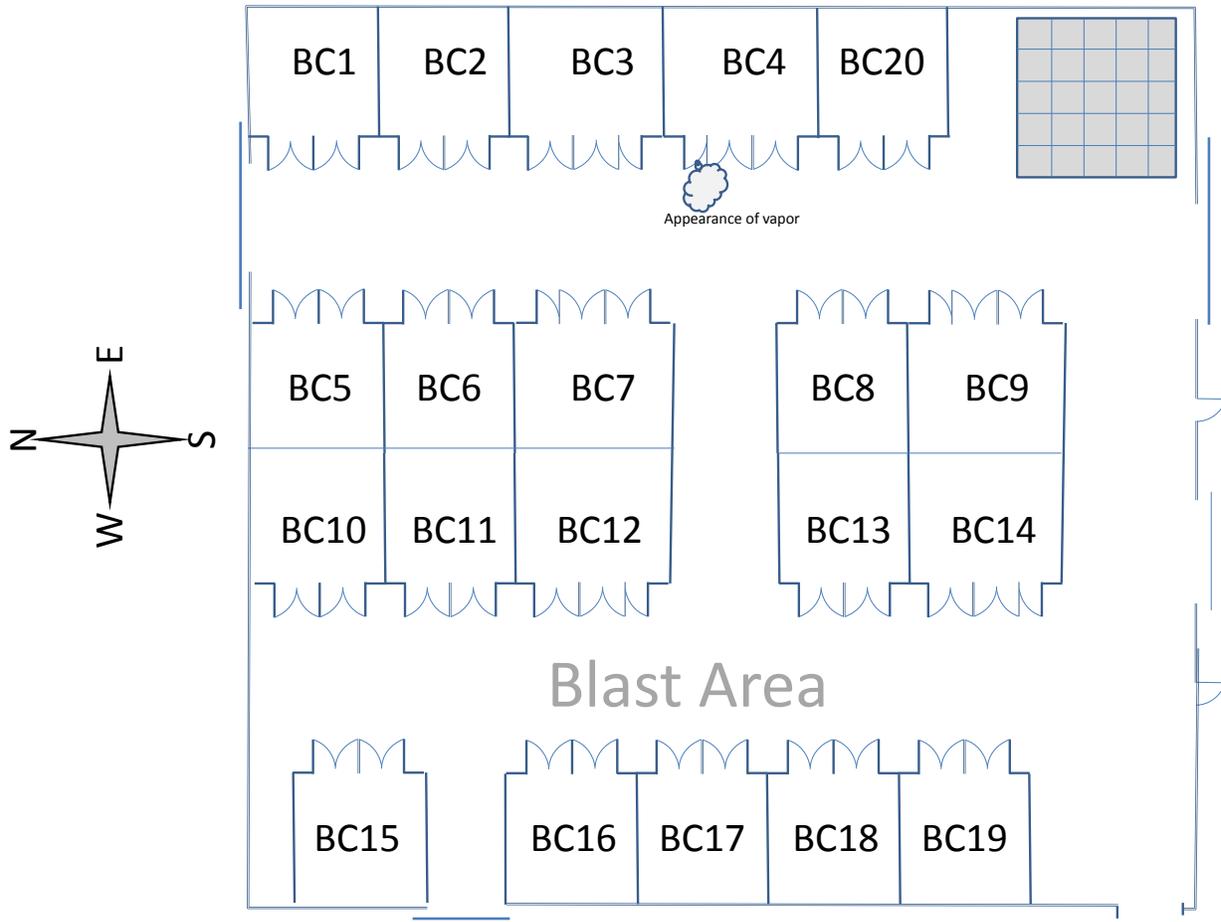
Figure 1: Plan view of plant blast cell area.

This facility is a production plant and the latter part of the production process involves moving finished products into stationary blast freezers or "blast cells" to rapidly freeze prior to shipping. A plan view of the plant's 20 independently operating blast cells is shown below in Figure 1.
