INCIDENT INVESTIGATION REPORT

Date of incident
October 17, 2017

Location of incident
**Fernie Memorial Arena
991 6th Avenue
Fernie, B.C.**

Investigation file number
FSI-REG-2017-0123

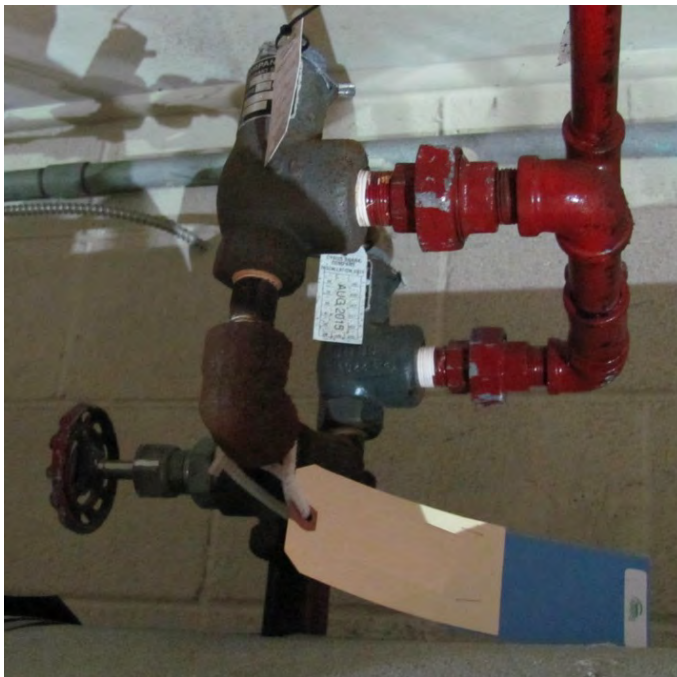
The curling rink chiller was fitted with two pressure-relief valves connected to a dual-port manifold (see Figure 17). The manifold was designed so that if flow to one valve was cut off, flow was always provided to the second valve. It was not possible to isolate both valves from flow at the same time. Although the two valves were manufactured at different times, they were both supplied by the same manufacturer and were installed on the same date in August 2015. The pressure-relief valve in service at the time of the incident was examined at the laboratory using high-powered digital microscopes in the presence of manufacturer representatives. There is no evidence to indicate that the pressure-relief valve had opened during the incident. The second pressure-relief valve was tested and found to be operating as intended. The factory-set opening pressure for each valve was 150 psi.

Figure 17: The pressure-relief manifold installed on top of the surge tank for the curling rink chiller.

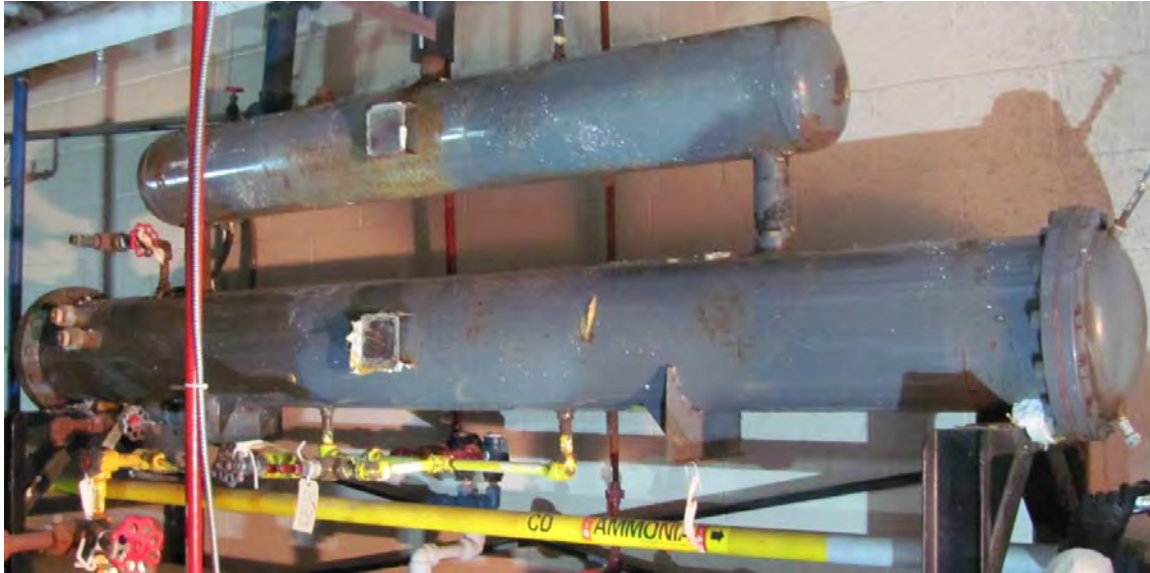
The curling rink chiller was examined in place. The insulated cladding was removed, and the exterior of the chiller showed minimal corrosion on the outside of the ammonia pressure shell. (See Figure 18.) The two dome-shaped end plates (heads) were removed in place. After the heads were removed, all of the gaskets were observed to be intact and in serviceable condition for their intended use.

Figure 18: The curling rink chiller with the insulated cladding removed.
