Accident Report

Ammonia Leak

San Nikunau

REPORT NO.: 05 3749

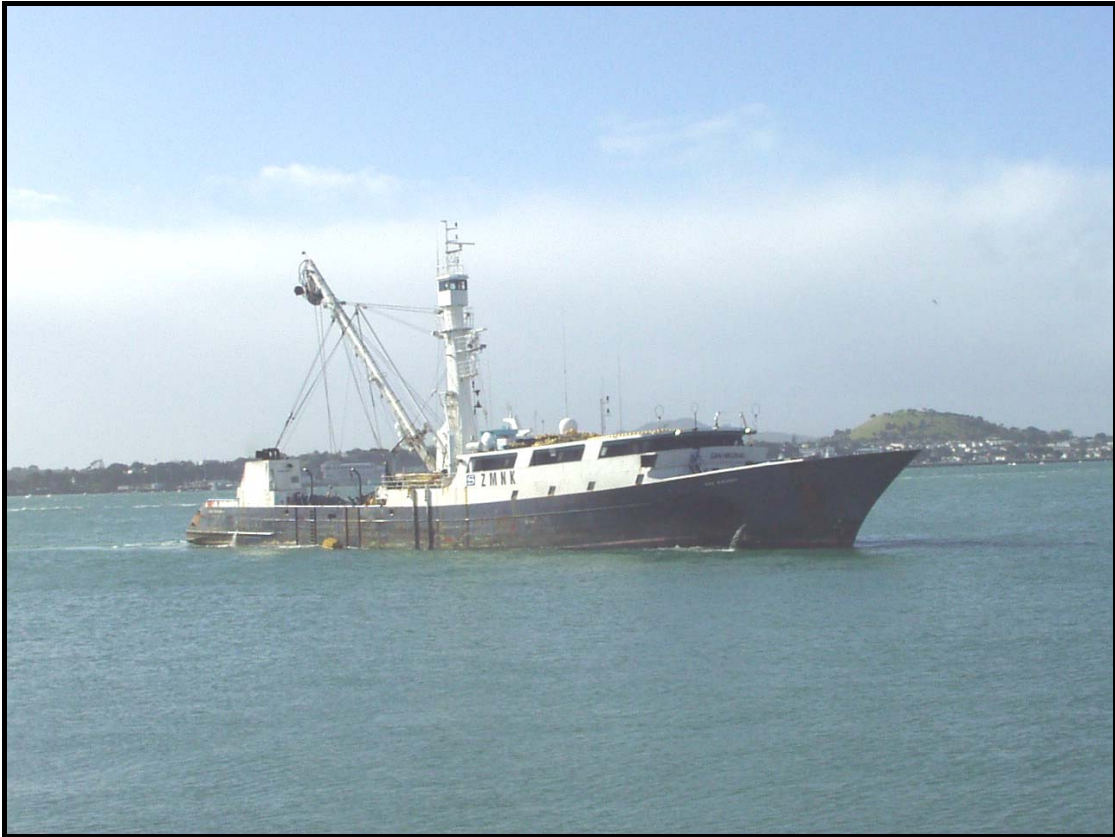
Shortly before 0215 hours, three crew including the Chief Engineer, were working in the pipe alley to reduce brine temperatures when a small ammonia gas leak was detected from a rusted section of the discharge line from the receiver. The Chief Engineer instructed the Assistant Engineer and Oiler to close valves to isolate the section of pipe whilst he went under the catwalk to check for further leaks. As the valves were being closed, but before the pipe could be isolated, it commenced venting a large quantity of ammonia. The Engineer ordered the crew to evacuate the pipe alley. As he left, he closed the king valves, however, the discharge continued as the venting pipe was not fully isolated. The two crew who were forward of the leak escaped by running aft, through the venting ammonia, and in so doing sustained ammonia burns to their legs and arms. (See Figures 1 & 2 - Photographs of the pipe alley showing area where ammonia vented & pipe that failed).
